Lidar Error Dictionary v. 3.2

October 2024

Developed and maintained by the
National Geospatial Technical Operations Center, Elevation Unit
Rolla, MO/Denver, CO

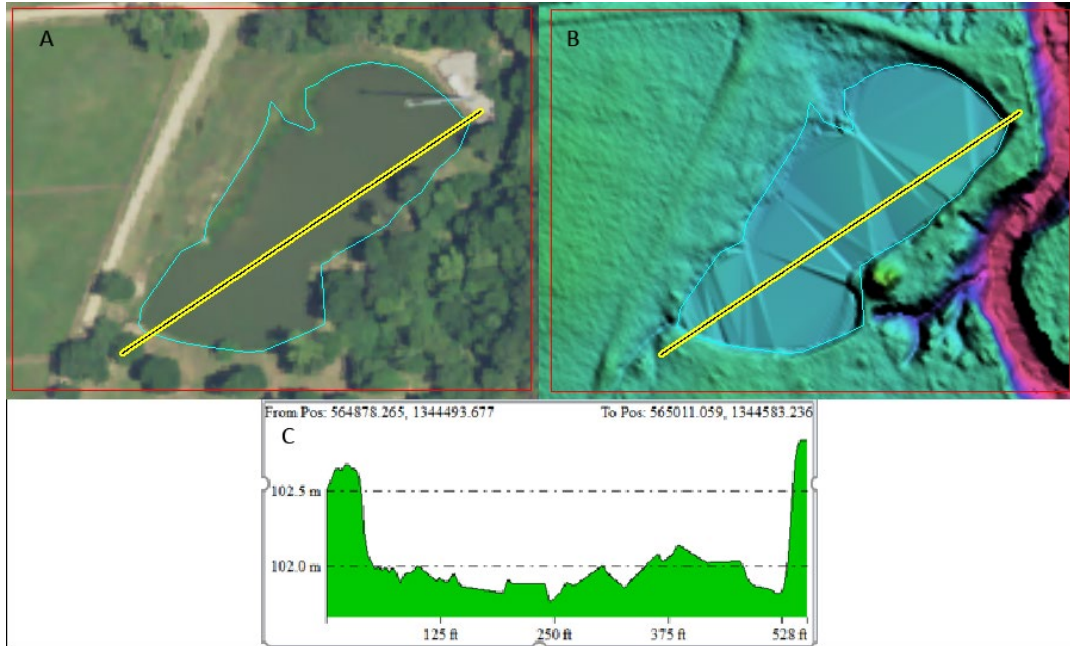
Breakline Enforcement

Appears as though the breakline was not enforced to the water feature, bridge, island, or structure correctly.

Figure 1. Lack of breakline enforcement. Breakline (blue) and cross-section line (yellow double line) overlain on aerial photo (A) and digital elevation model (B). Elevation cross section (C) shows varying elevation that would be monotonic across the waterbody if the breakline had been properly enforced.

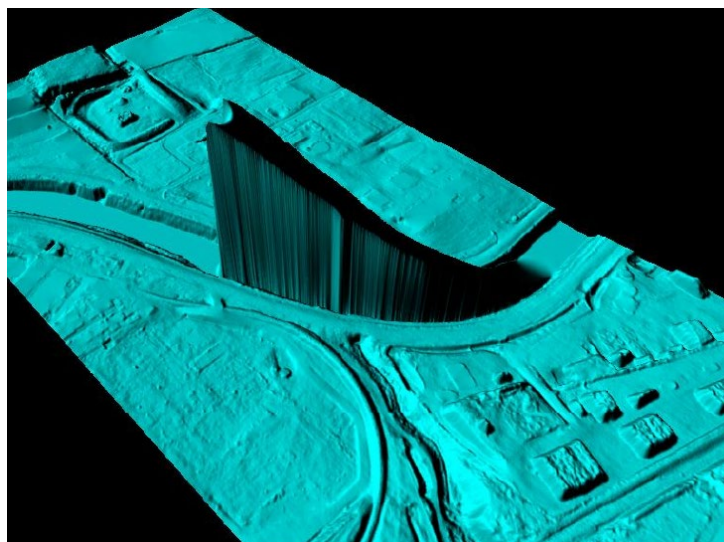
Downstream Constraint

Water feature does not present a gradient downhill surface that follows the immediately surrounding terrain.

Figure 2. Digital elevation model showing an error in a downstream constraint. The water surface should have a downhill gradient following the surrounding terrain.

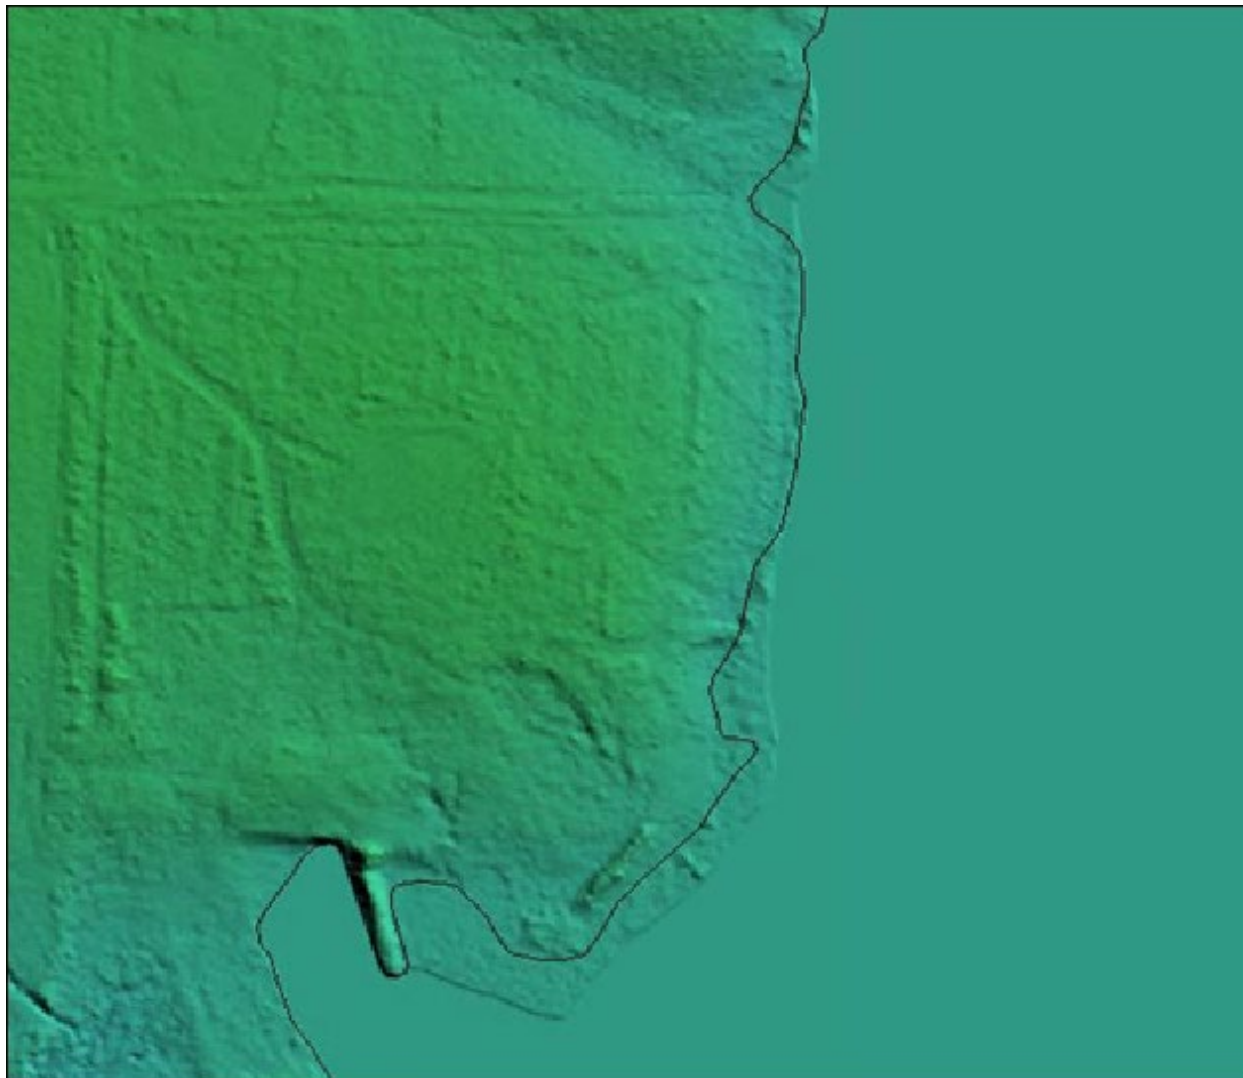
Over Extended Breakline

Breakline that goes beyond the full extent of the water body.

Figure 3. Digital elevation model showing a breakline (black) that does not follow the edge of the waterbody but instead is overextended landward. There should not be land on the waterward of the breakline.

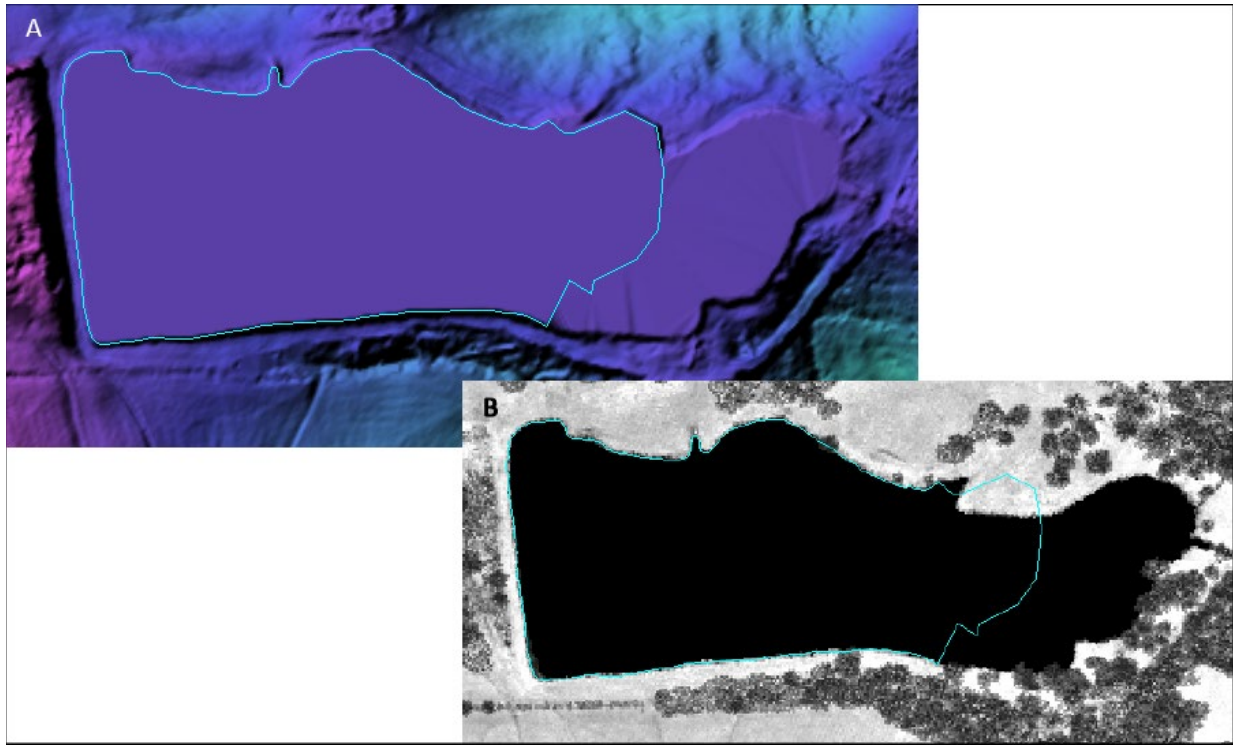
Under Extended Breaklines

Breakline that underrepresents the full extent of the water body.

Figure 4. In this digital elevation model (A), a breakline (blue) does not follow the edge of the waterbody but instead is underextended. The intensity image (B) clearly shows water beyond the breakline. This breakline is also underextended in places (see figure 3).

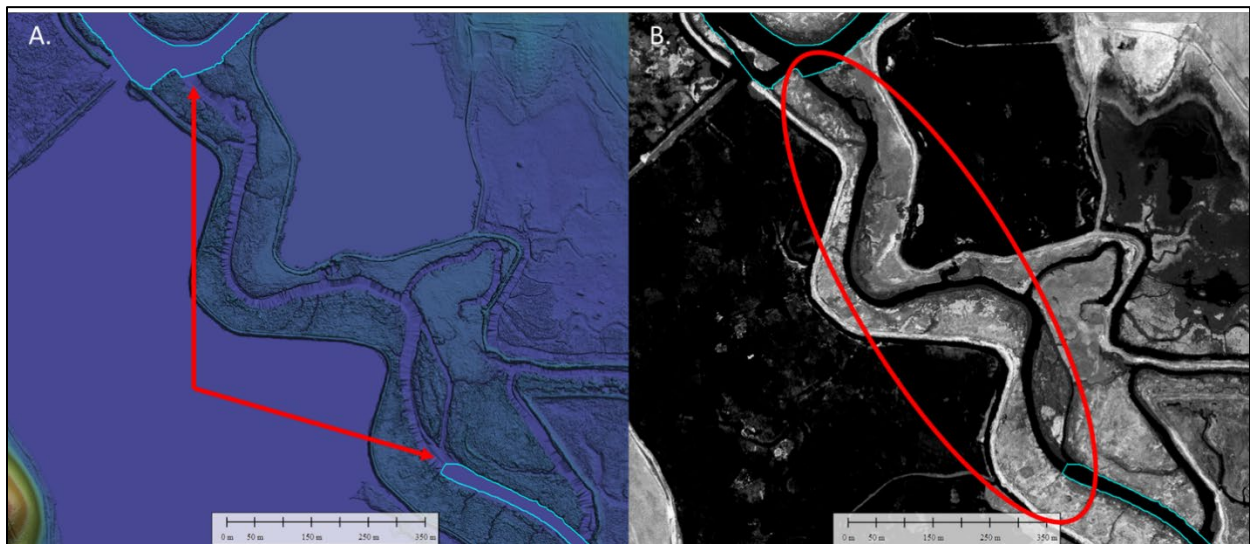
River/Stream Segment

A stream or river feature that is broken up into discontinuous segments when it should be a single collected water feature.

Figure 5. Digital elevation model (A) and intensity image (B) showing a discontinuous stream segment that should have been collected as a single water feature.

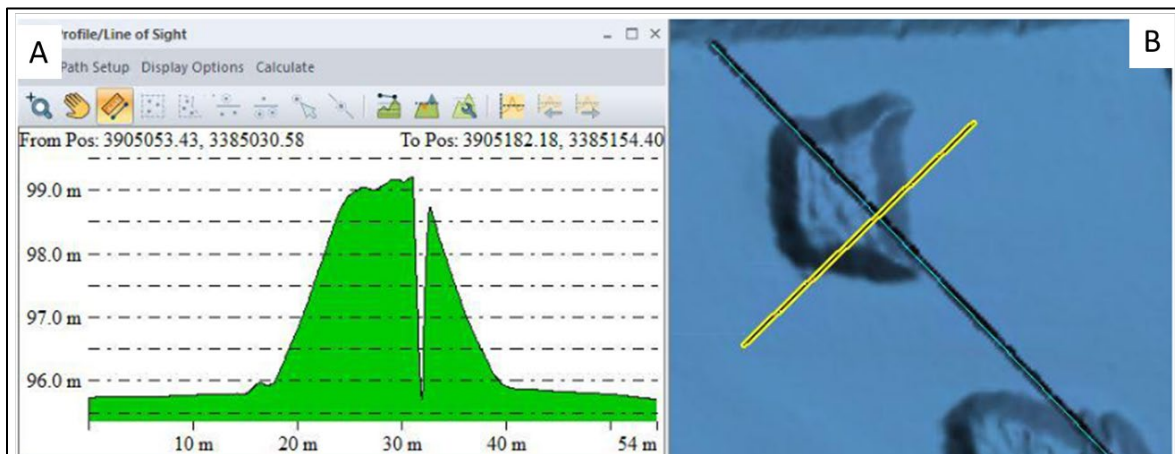
Misplaced Breakline

A breakline whose placement is erroneous and/or compromises the quality of the DEM surface. For example, a breakline that does not delineate a feature or alters elevation values in a way that is undesirable.

Figure 8: Image on right (B), showing a breakline that's not delineating a feature and is disrupting the DEM surface. Profile of area seen in image A.

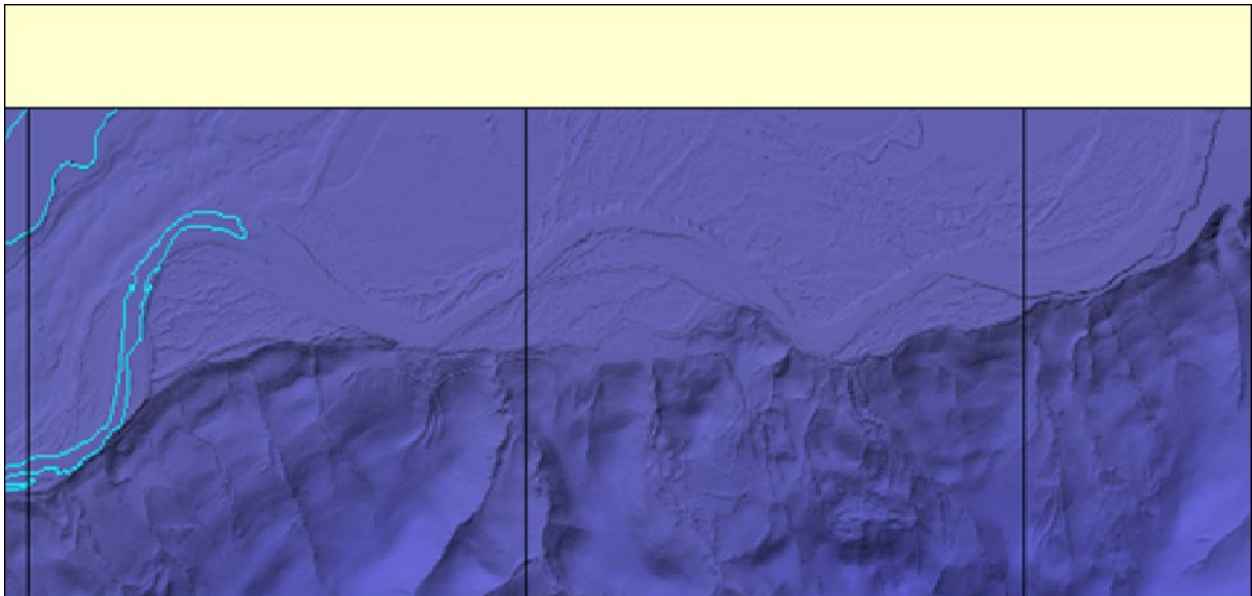
Missing Breakline

A segment or piece of a breakline on a feature that is missing.

Figure 9. Digital elevation model showing a missing feature. The blue breakline should have continued along the river.

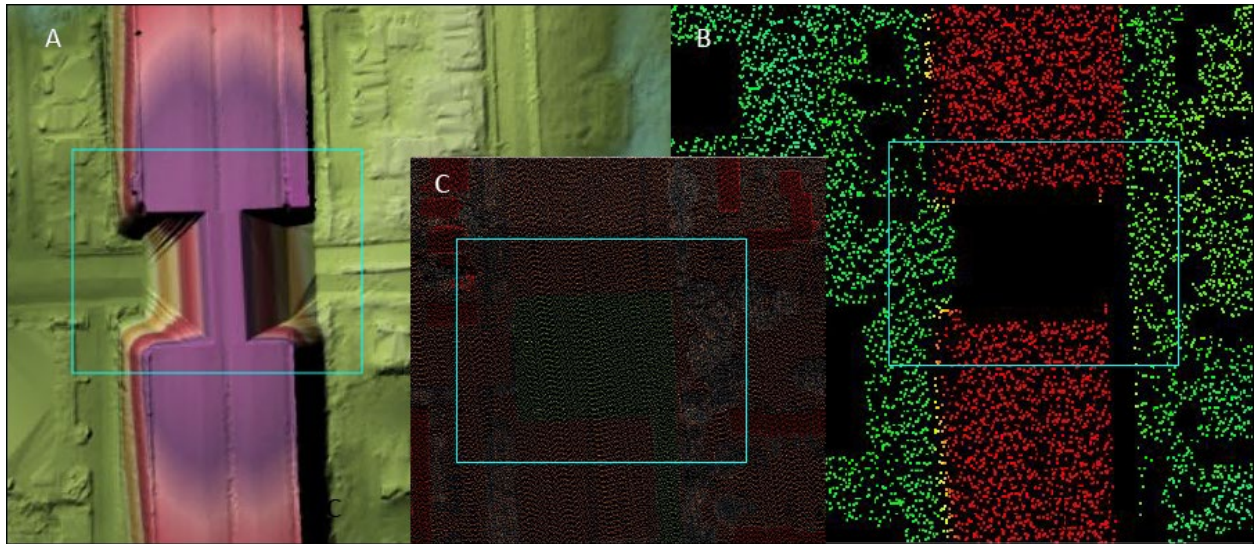
Missing Bridge Breakline

There is a bridge artifact, not caused by a point misclassification, that requires a breakline in order to remove it completely.

Figure 10. Digital elevation model (DEM) (A), point cloud colored by elevation (B), and classified point cloud (C) showing a bridge that is classified correctly, as can be seen in the center and right images, but lacks sufficient breaklines leading to artifacts in the DEM.

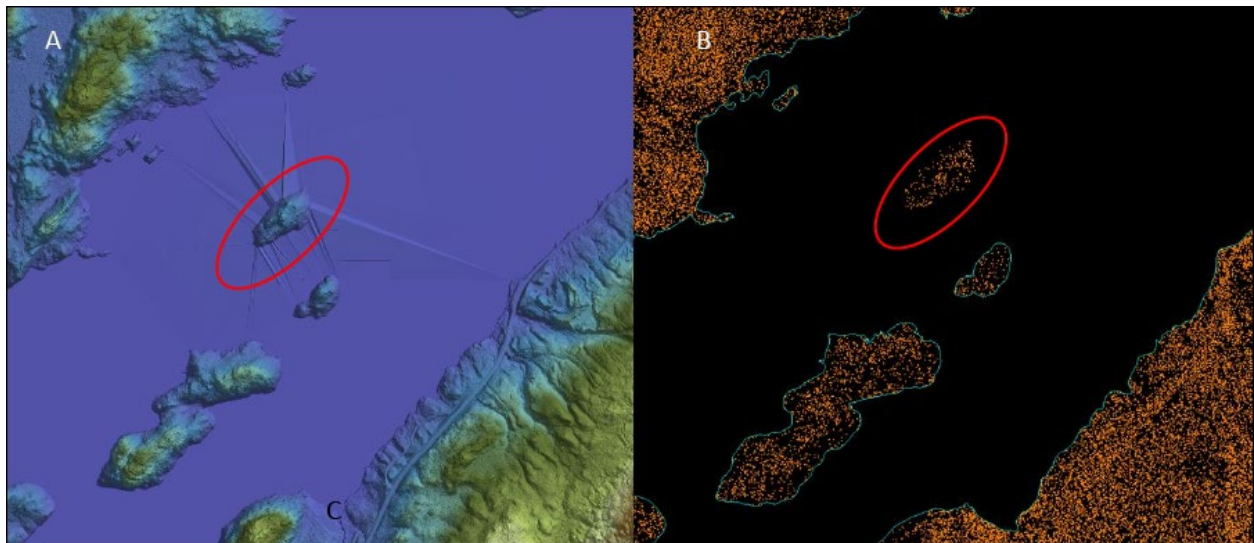
Missing Island Breakline

There is an island greater than the contracted collection size that is not encompassed with a breakline.

Figure 11. Digital elevation model (A) and classified lidar point cloud (B) showing an island (in red ellipse) that is classified correctly but is missing a breakline leading to an uneven water surface. The water surface should be flat. This island meets contracted minimum collection size for breaklines.

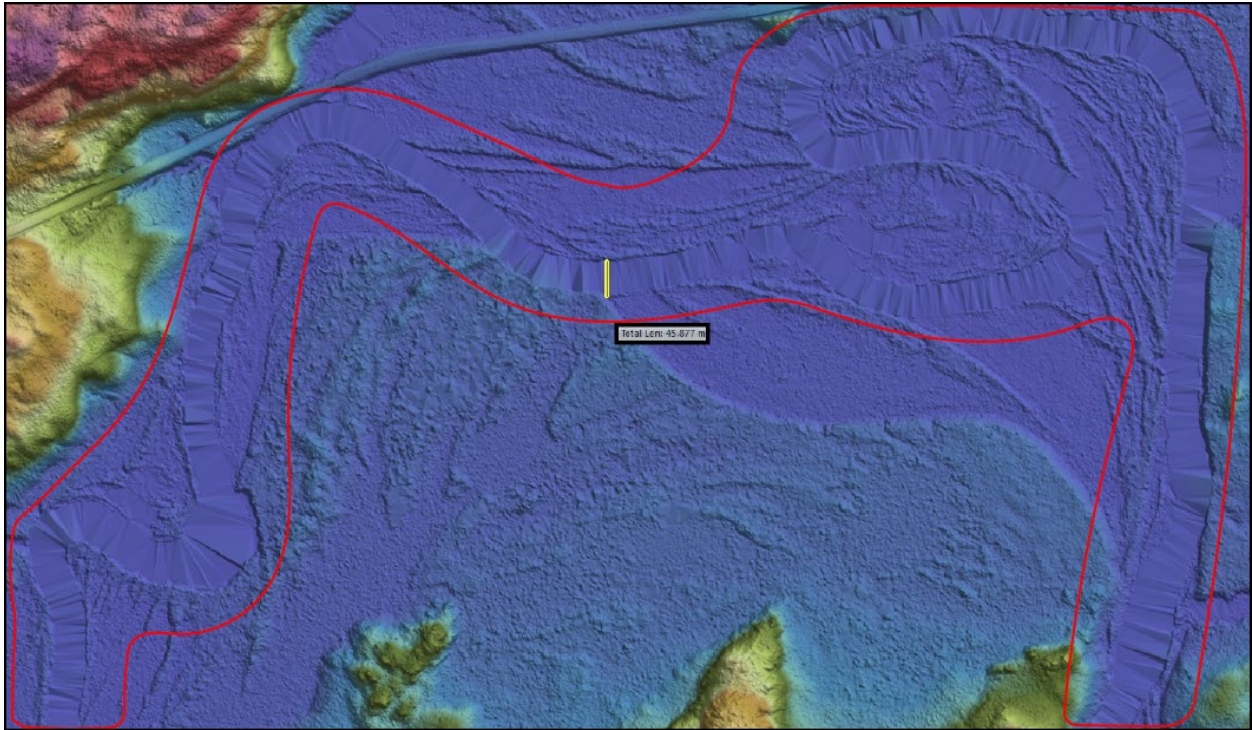
Missing Stream/River Breakline

There is a river or stream that meets the contracted collection size that is

not encompassed with a breakline.

Figure 12. Digital elevation model showing a river (in red polygon) that is not encompassed with a breakline and so is left unflattened. This river meets contracted collection size for waterbodies requiring breaklines.

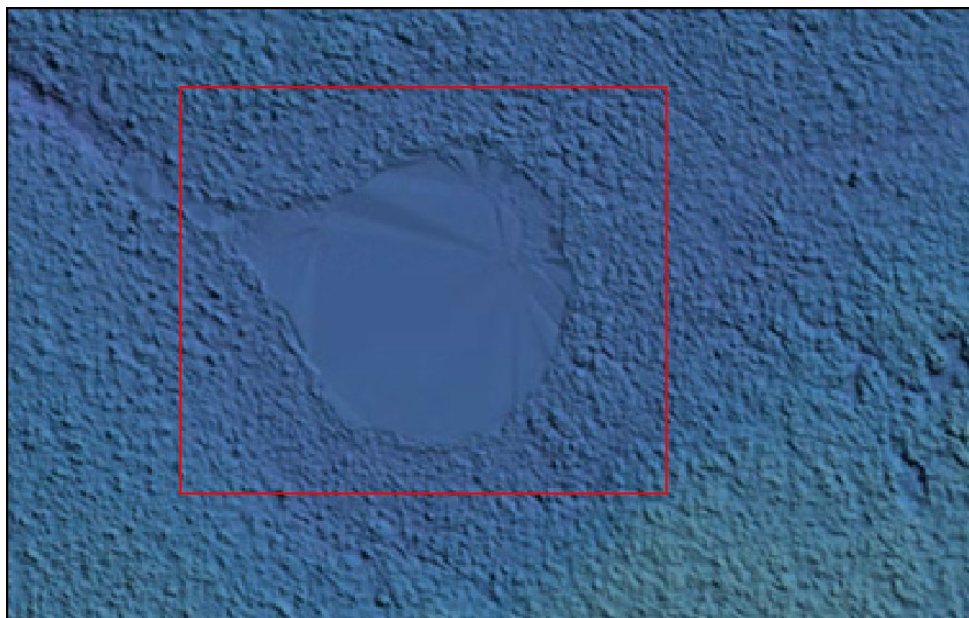
Missing Waterbody Breakline

There is a waterbody that meets the contracted collection size that is not encompassed with a breakline.

Figure 13. Digital elevation model showing a waterbody not encompassed with a breakline. This waterbody meets the contracted collection size for waterbodies requiring breaklines.

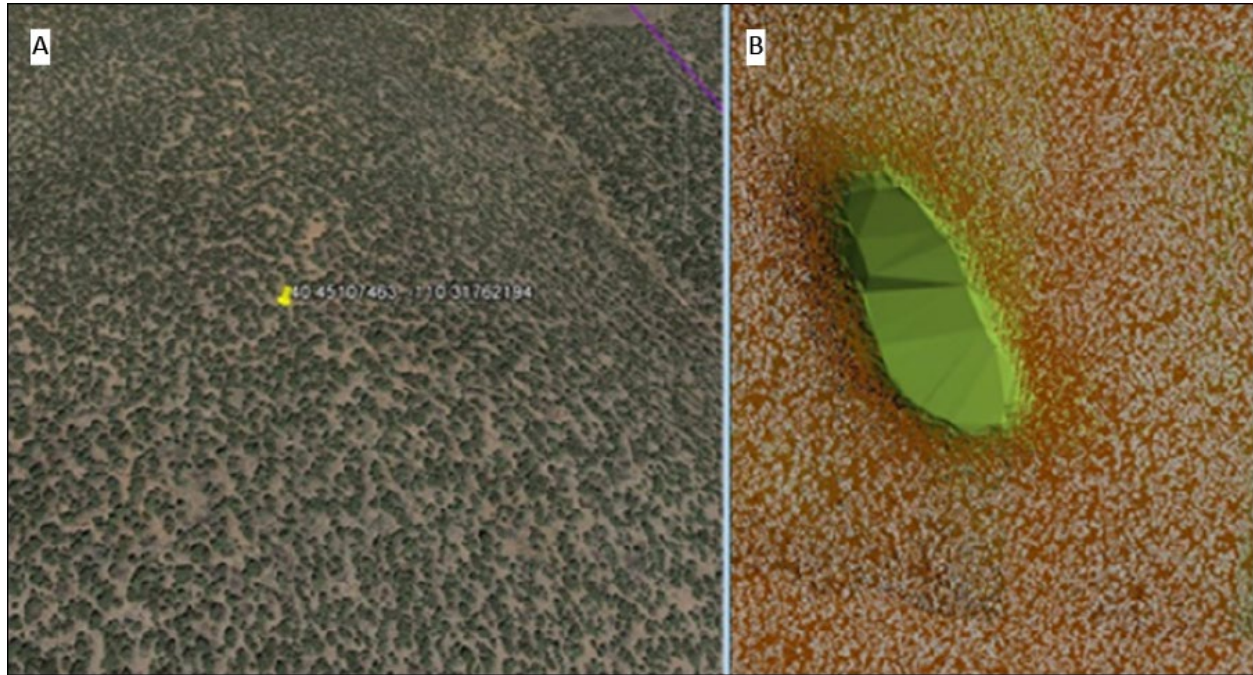
Point Cloud Data Void

Lapses in lidar data collection in the point cloud that are not due to surface environmental conditions. Examples would include but are not limited to lapse in coverage due to atmospheric interference, GPS outages, or cloud cover.

Figure 14. Aerial imagery (A) and classified lidar point cloud (B) showing a void in the point cloud (green area in B).

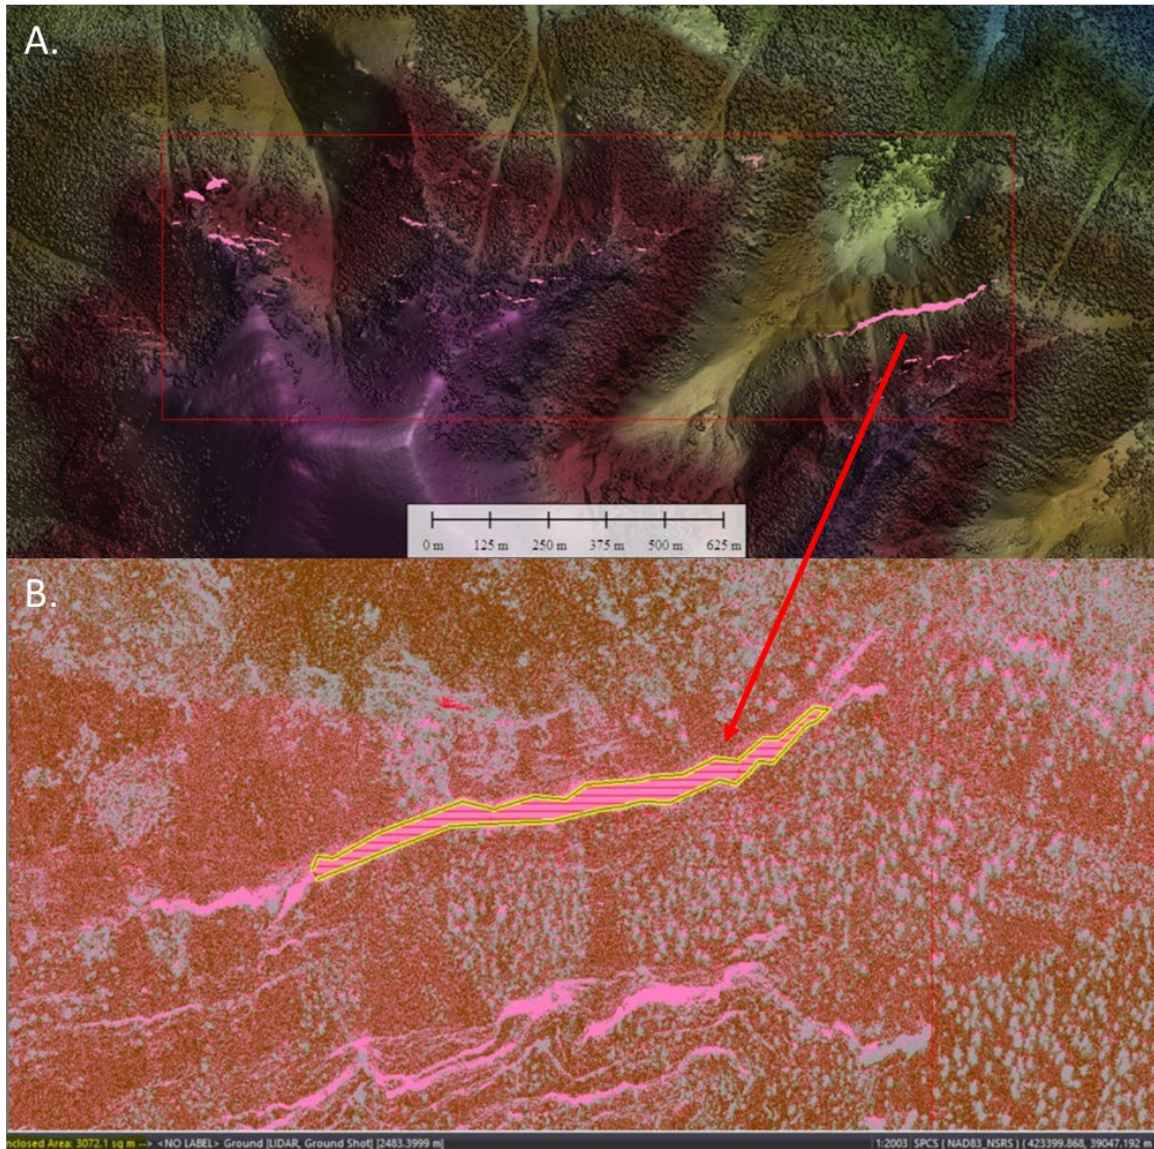
Point Cloud Data Void

Figure 15. Maximum Surface Height Raster (A) and Lidar Point Cloud (B) showing a void in the point cloud (Pink areas showing through loaded data and area circled in yellow lines in B) that measures more than 3,072 sq meters.

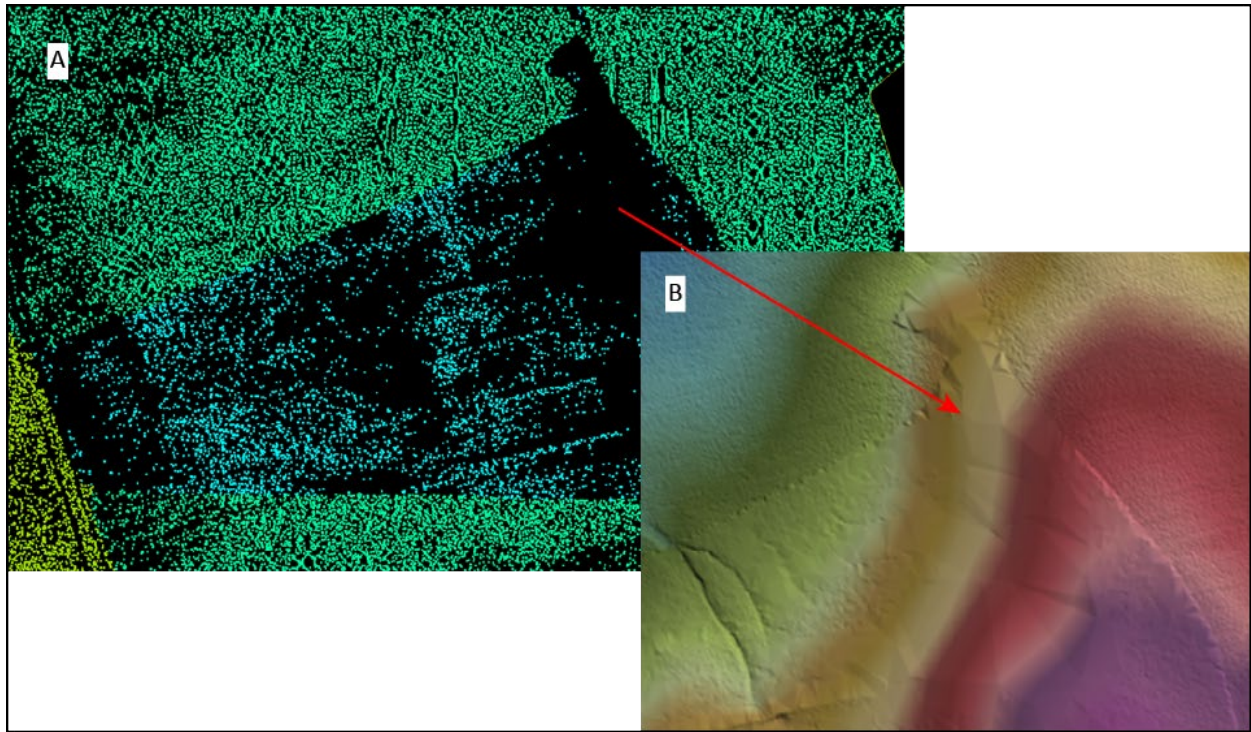
Density

Point density for specific file(s) appears to be excessively high or low compared to the expected values.

Figure 16. Classified point cloud (A) with an area of lower point density that detrimentally affects the digital elevation model (DEM) (B). An area with TIN artifacts can be seen in the DEM in the area of lower density.

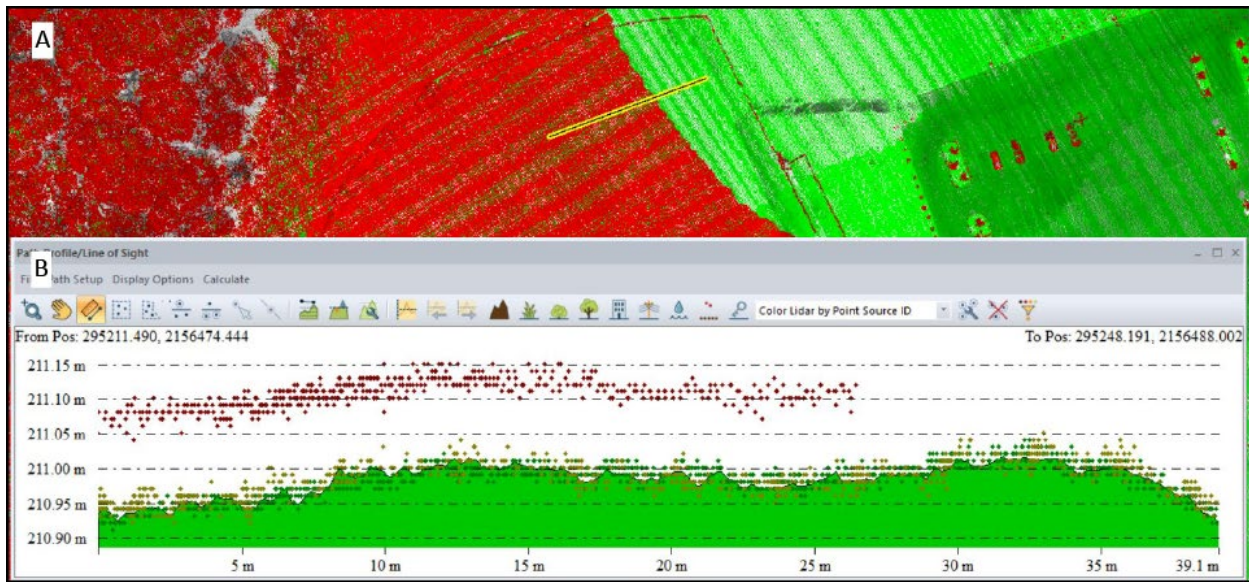
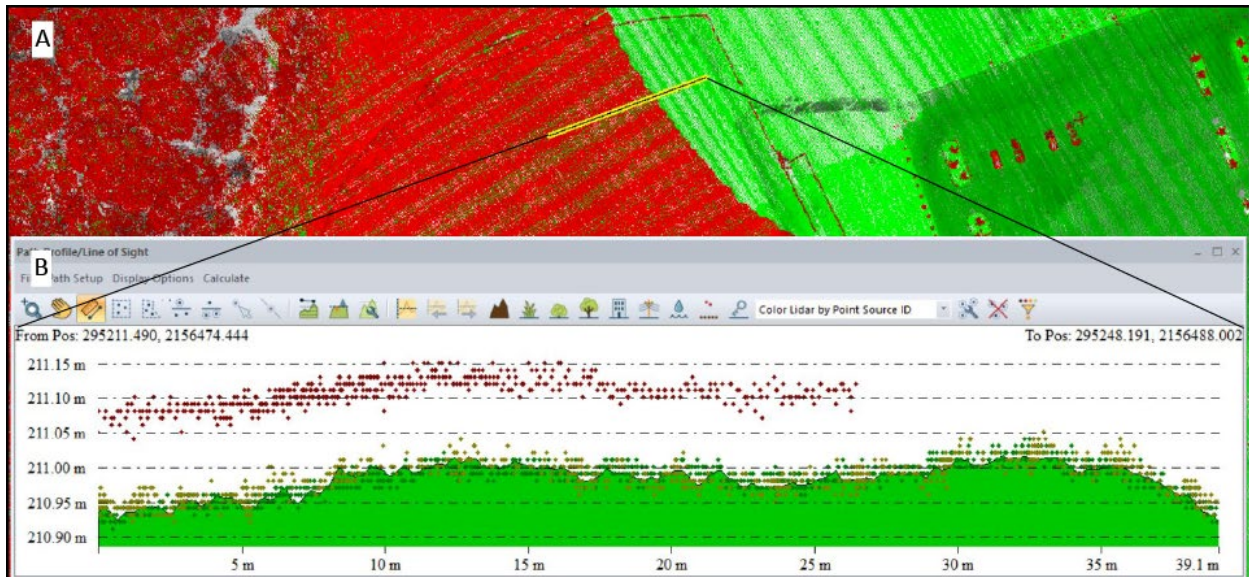
Relative Accuracy (Interswath)

Issues pertaining to the geometric accuracy of the point cloud. These errors can be related to the interswath and intraswath precision and may or may not have visual indication in the DEM surface.

Figure 17. Classified point cloud (A) and elevation cross-section (B, taken along yellow double line in top image) illustrating an elevation mismatch between swaths (red and green).

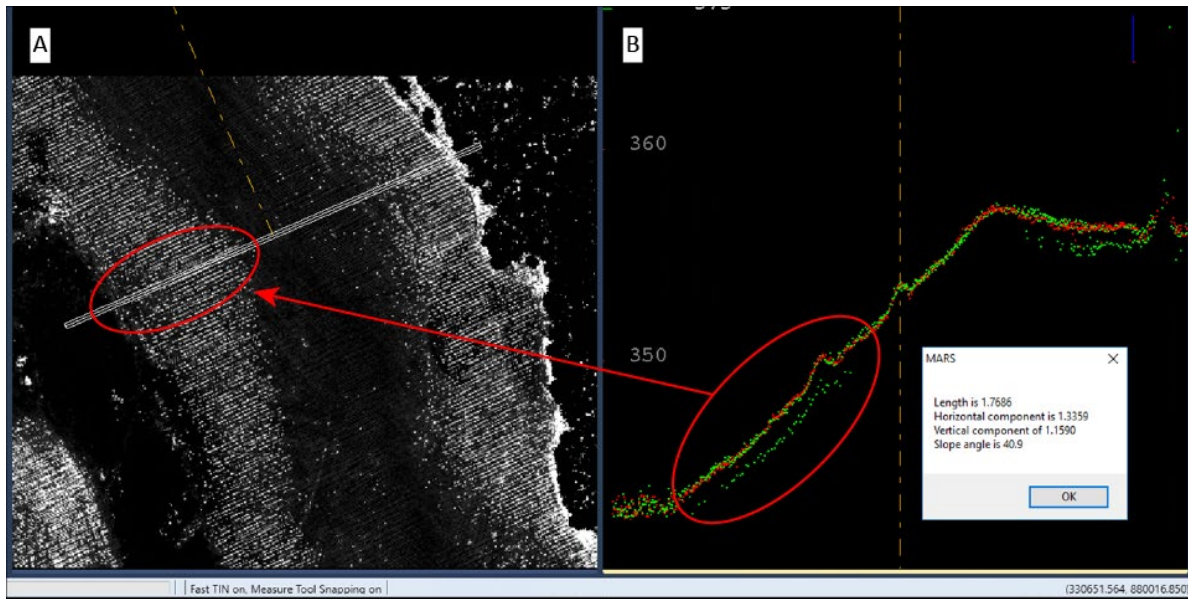
Relative Accuracy (Intraswath)

Figure 18. Lidar point cloud by channel (A) and elevation cross section (B, along double-line in left image) showing an elevation error between intraswath channels. The vertical difference is greater than one foot.

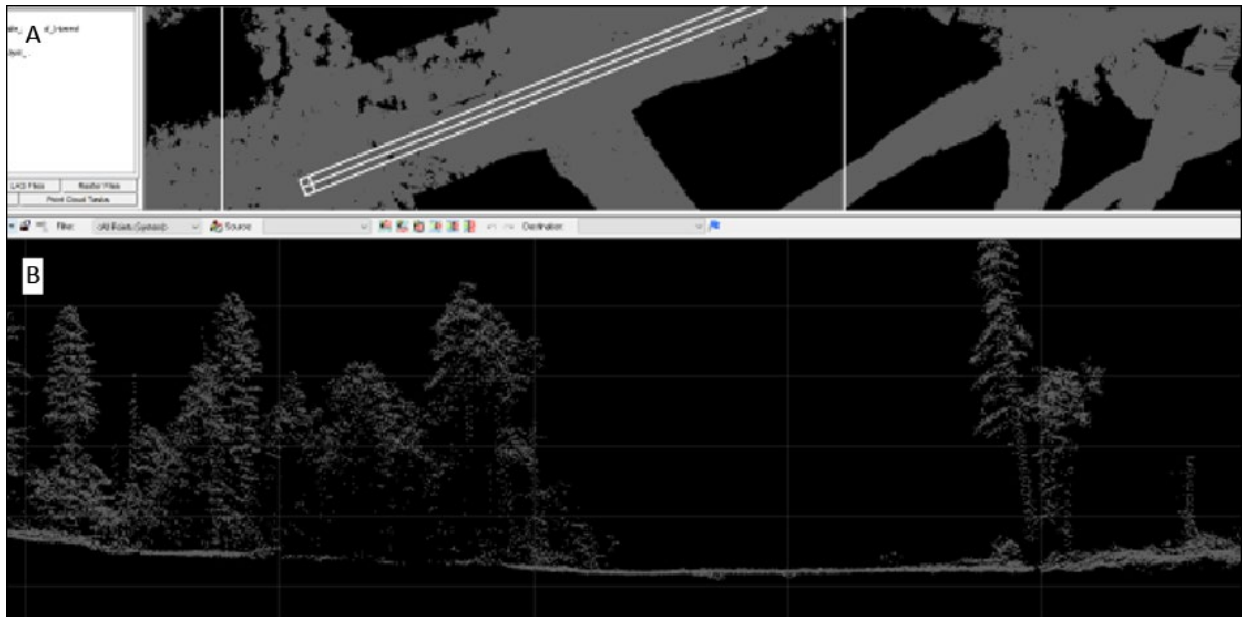
Classification Flags - Overlap

Classification flags are set incorrectly. This includes overlap, withheld, key-point, and synthetic flags. Text field will be used to specify.

Figure 19. Points flagged as overlap are not properly classified. Plan view (A) and cross-section (B) in overlap area shows points remaining unclassified.

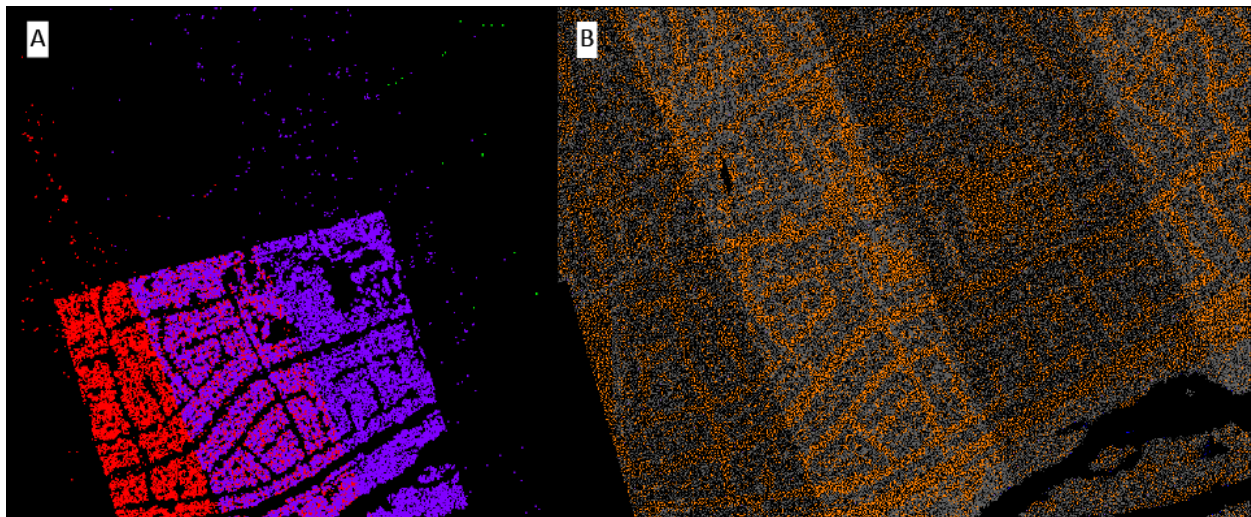
Classification Flags - Withheld

Figure 20. Geometrically valid points flagged as withheld (A, colored by swath). Points in B are colored by classification and shaded by swath.

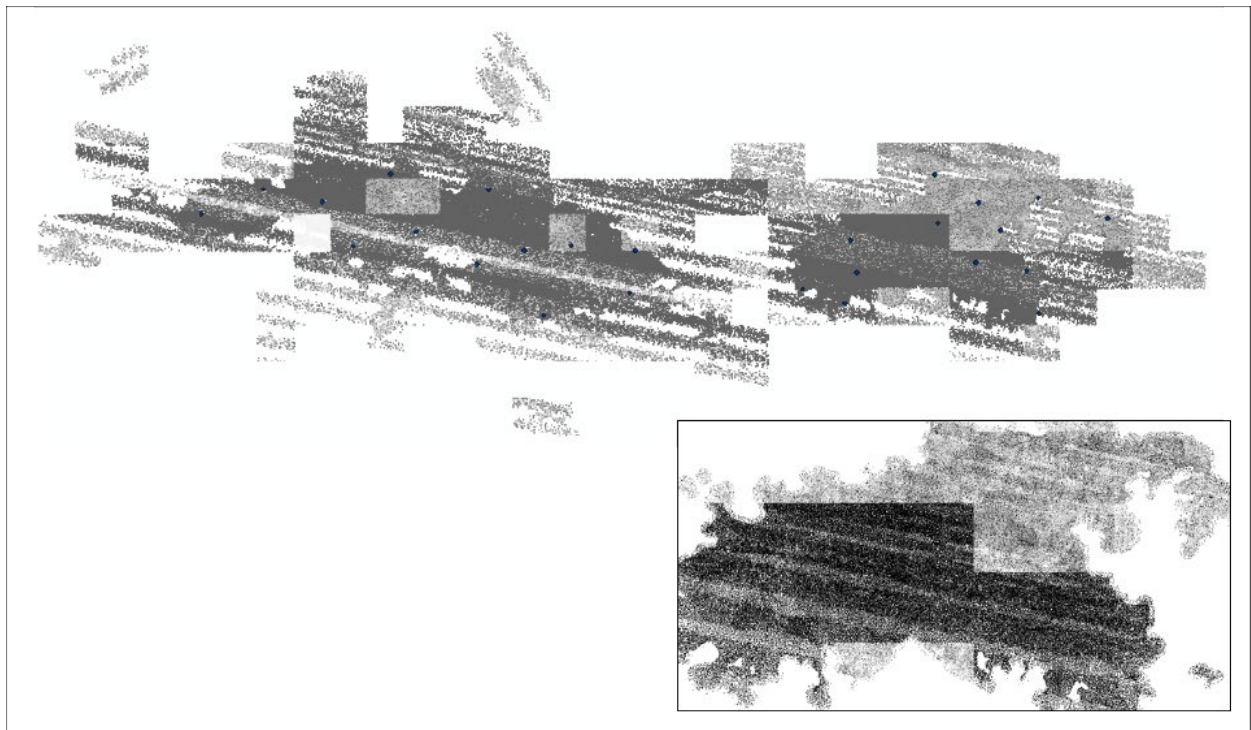
Intensity values of the LAS points are not normalized to 16 bit and/or did not use linear normalization.

Figure 21. Image of LAS intensity values showing inconsistent normalization.

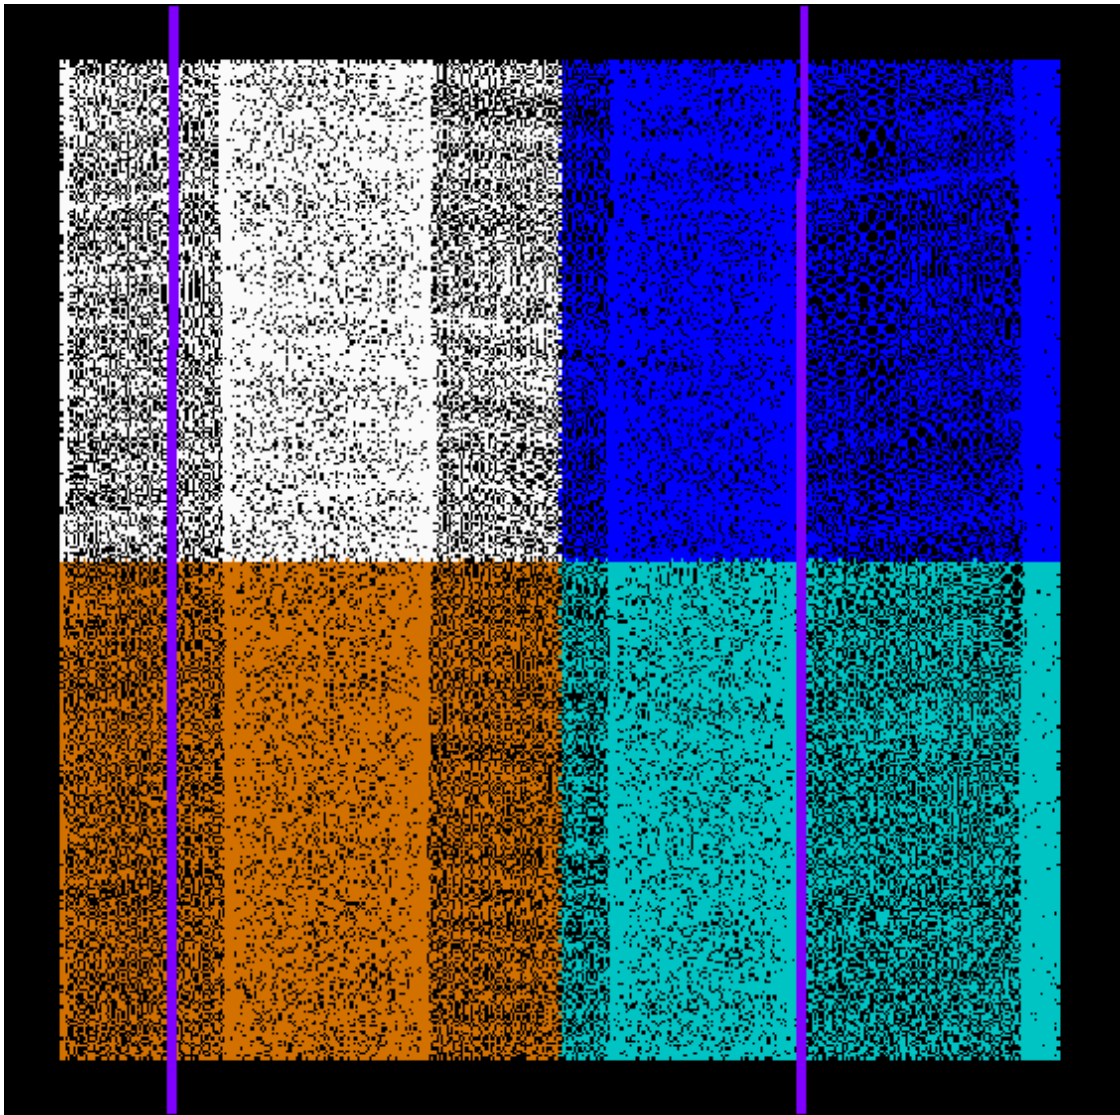
Point Source ID values are set incorrectly.

Figure 22. A lidar point cloud colored by Point Source ID. The Point Source IDs in this dataset have been set incorrectly and do not align with the flight lines (purple).

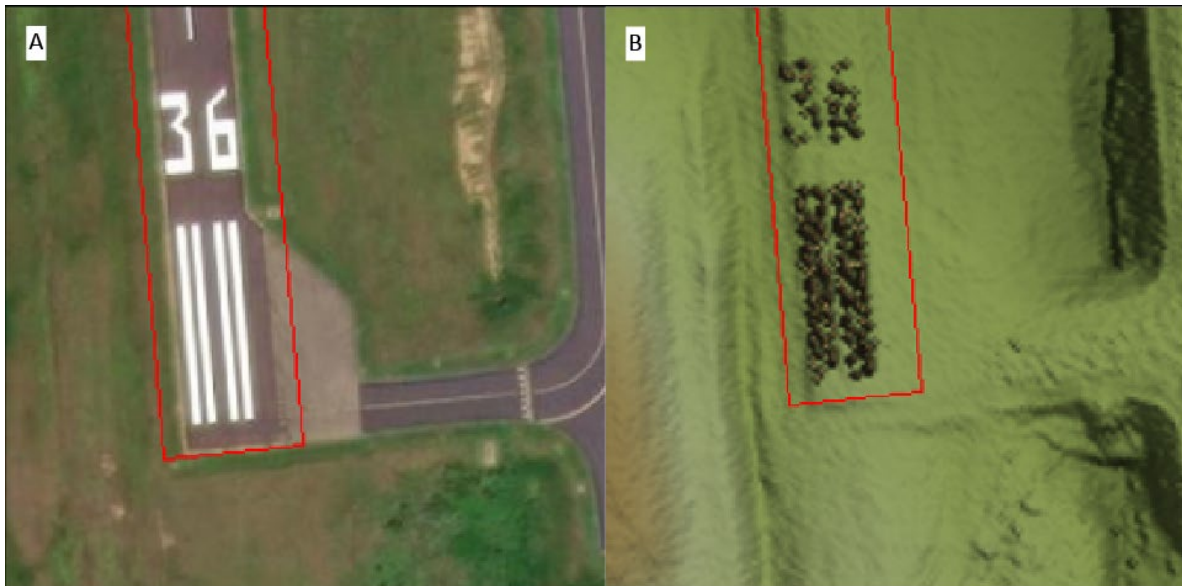
Misclass 1

Figure 23. High noise from reflective surfaces on a runway (aerial photograph, A) have been left in the ground classification (digital elevation model, B).

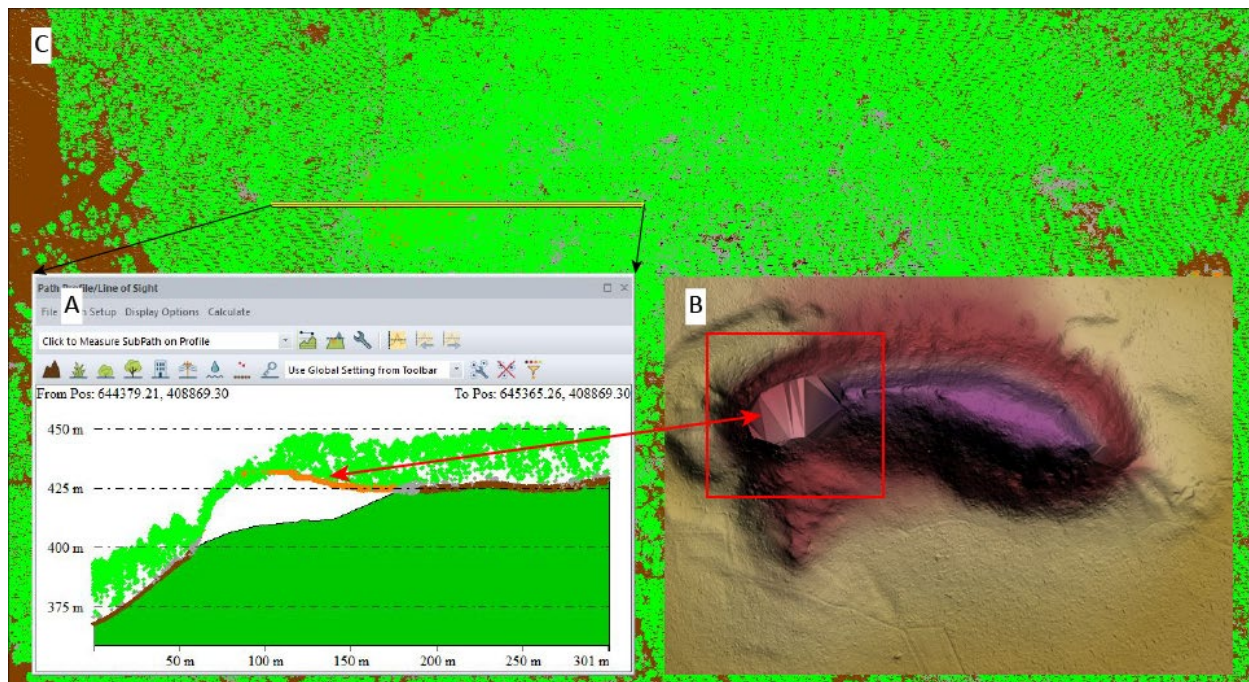
Misclass 2

Figure 24. Elevation profile (A) and digital elevation model (B) show a void due to misclassification of ground points. Elevation profile taken along double line shown in lidar point cloud image (background, C).

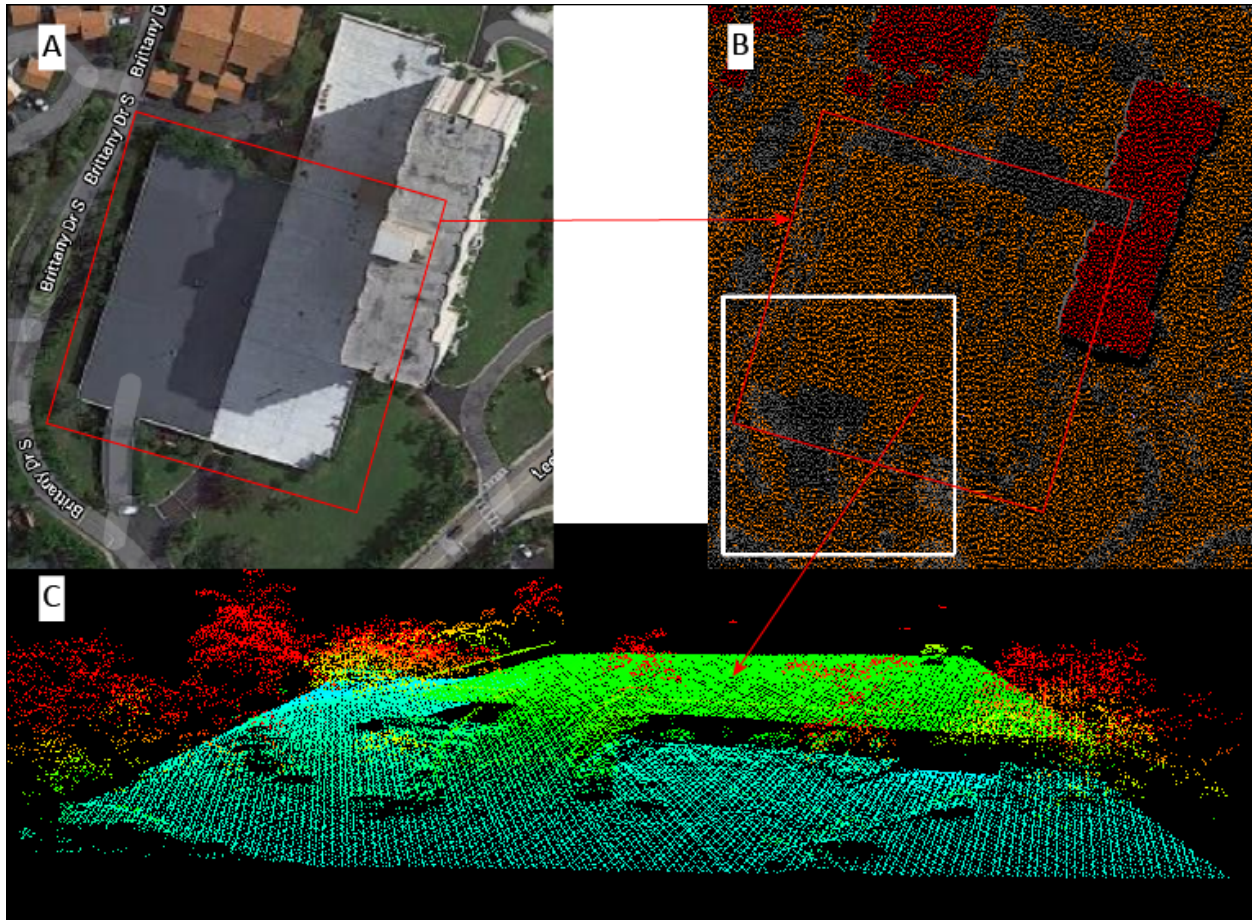
Misclass 3

Figure 25. In this set of images, an elevated parking garage (aerial photograph, A) has been classified as ground. This can be seen in the lidar point cloud colored by classification (B) and by elevation (C).

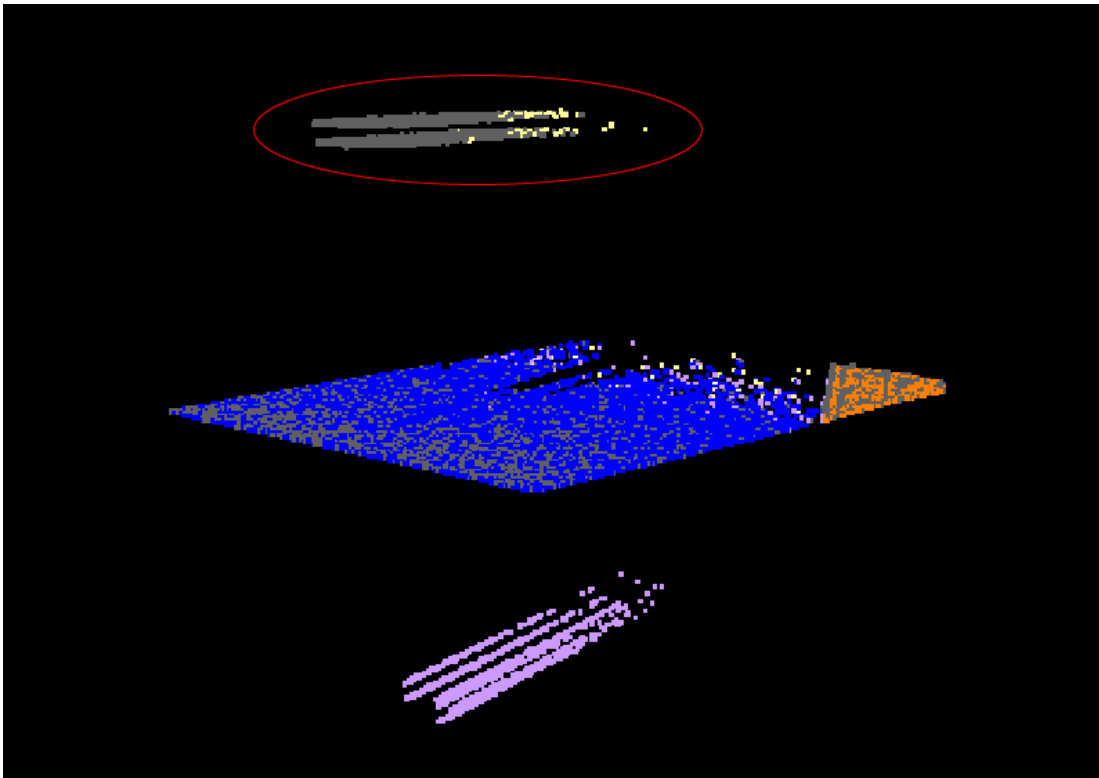
Misclass 4

Figure 26. High noise (circled, top) has been left in class 1.
