Lidar Error Dictionary v. 3.2

October 2024

Developed and maintained by the
National Geospatial Technical Operations Center, Elevation Unit
Rolla, MO/Denver, CO

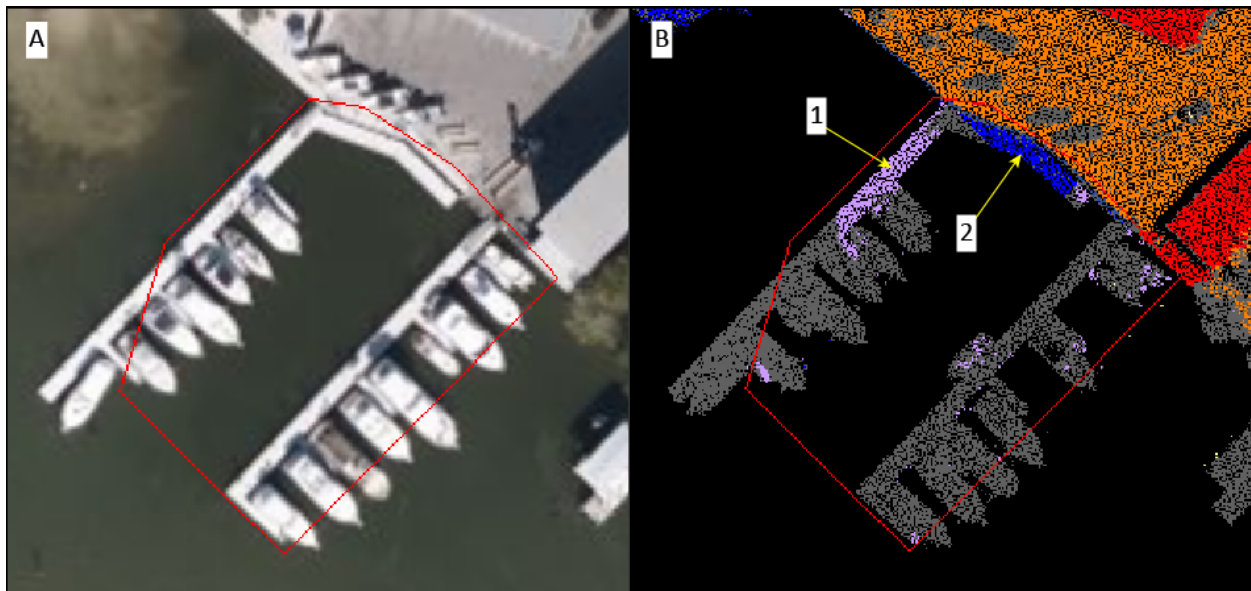
Misclass 5

Figure 27. A dock (aerial photograph, A) has sections that have been misclassified as low noise (purple, 1) and water (blue, 2) in the classified point cloud (B).

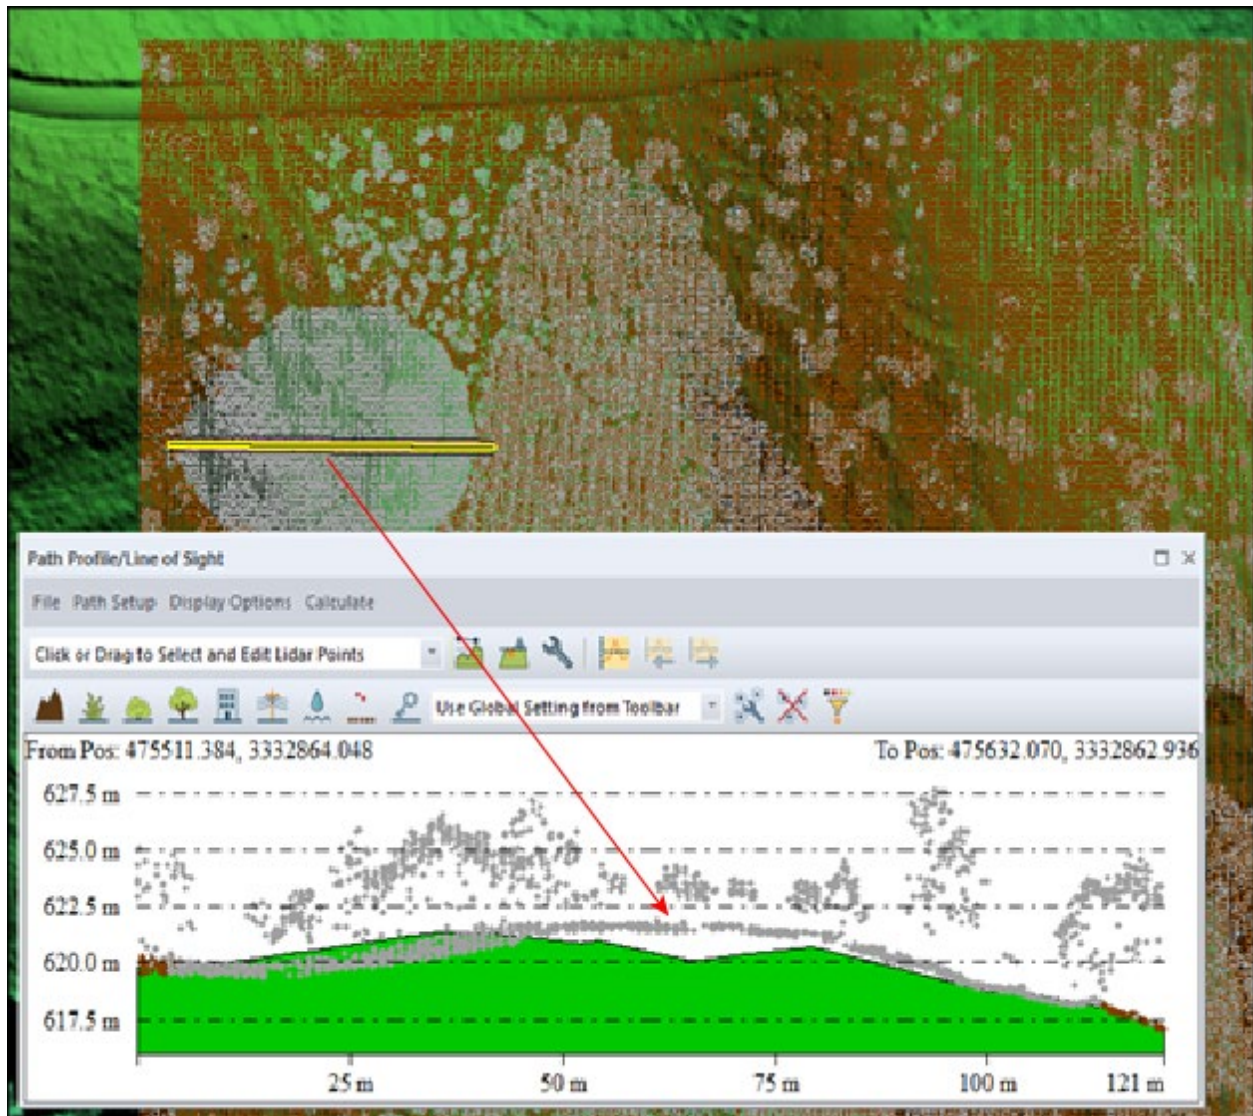
Misclass 6

Figure 28. Elevation profile showing ground points that have been misclassified as unclassified (gray points).
Elevation profile along yellow double line in classified point cloud image.

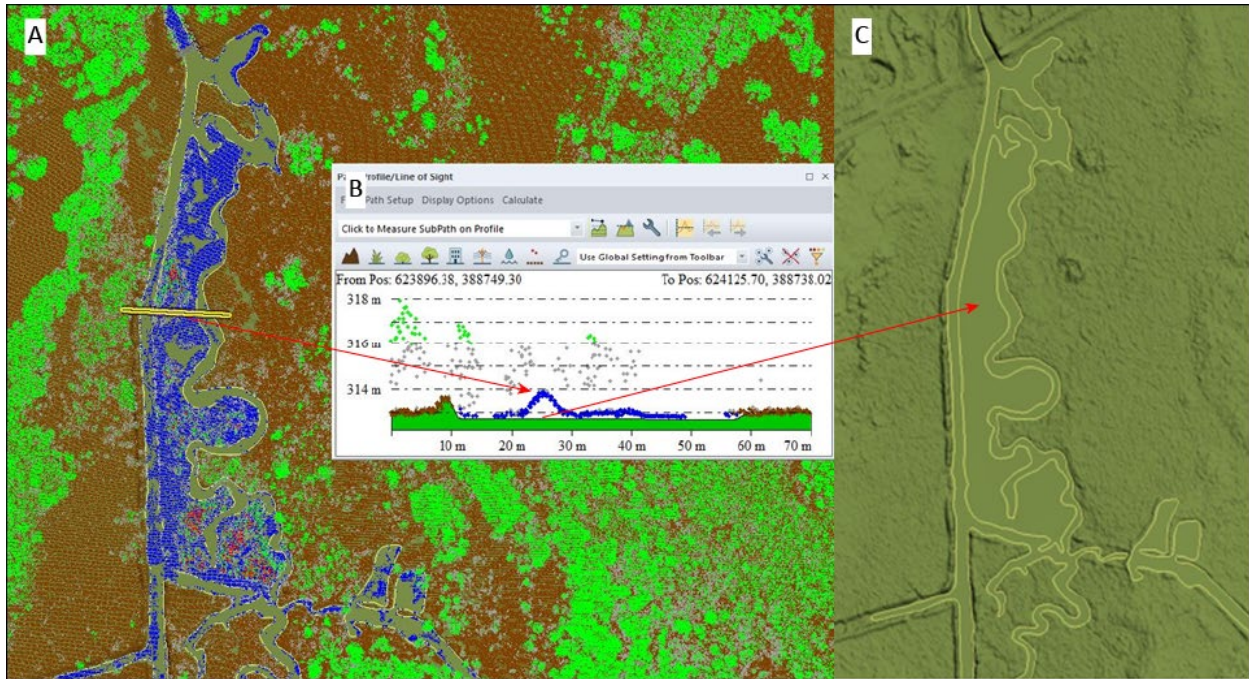
Misclass 7

Figure 29. Elevation profile (B, along yellow double line shown in classified point cloud, A) shows ground points that have been misclassified as water (blue points) and inappropriately hydroflattened as seen in the digital elevation model (C) showing breakline (yellow line).

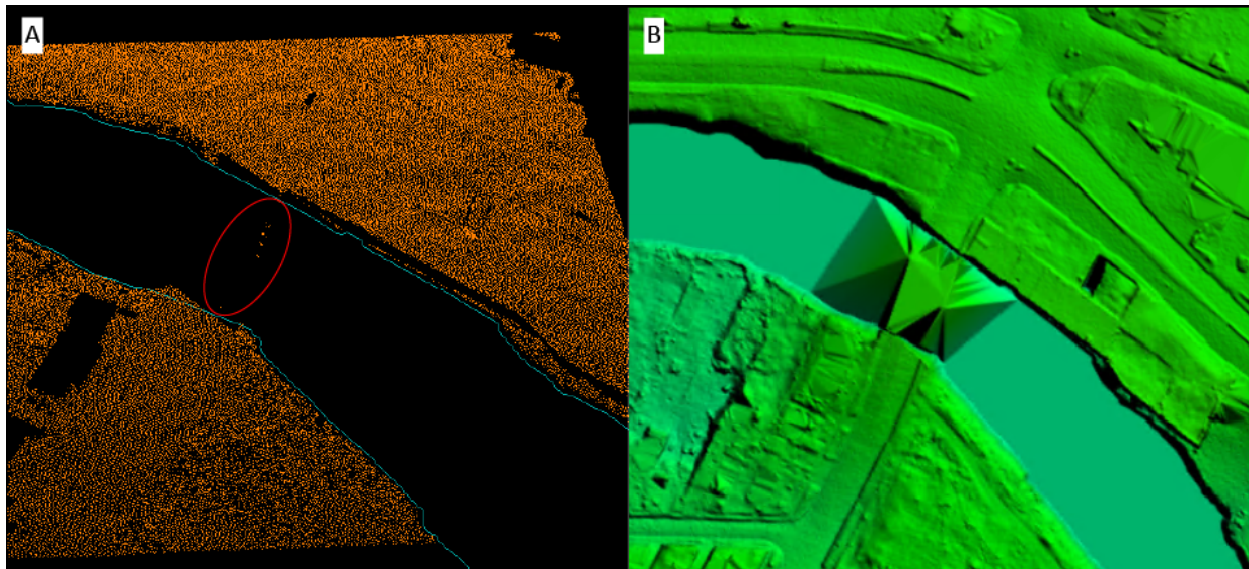
Misclass 8

Figure 30. Points on a bridge deck have been left classified as ground (brown points, classified point cloud, A). This causes an incomplete removal of the bridge as seen in the digital elevation model (B).

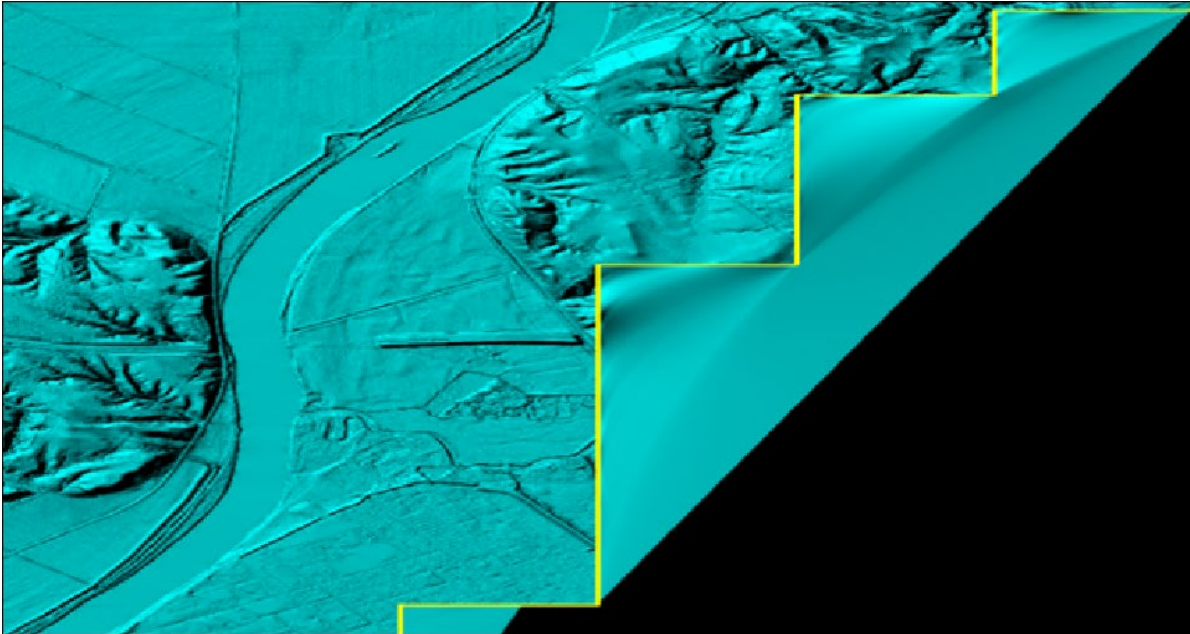
Interpolation

Any artifacts relating to interpolation of the DEM from the lidar point cloud that appear erroneous. This is to include edge artifacts.

Figure 31. The digital elevation model has been extrapolated beyond the DPA boundary (yellow line).

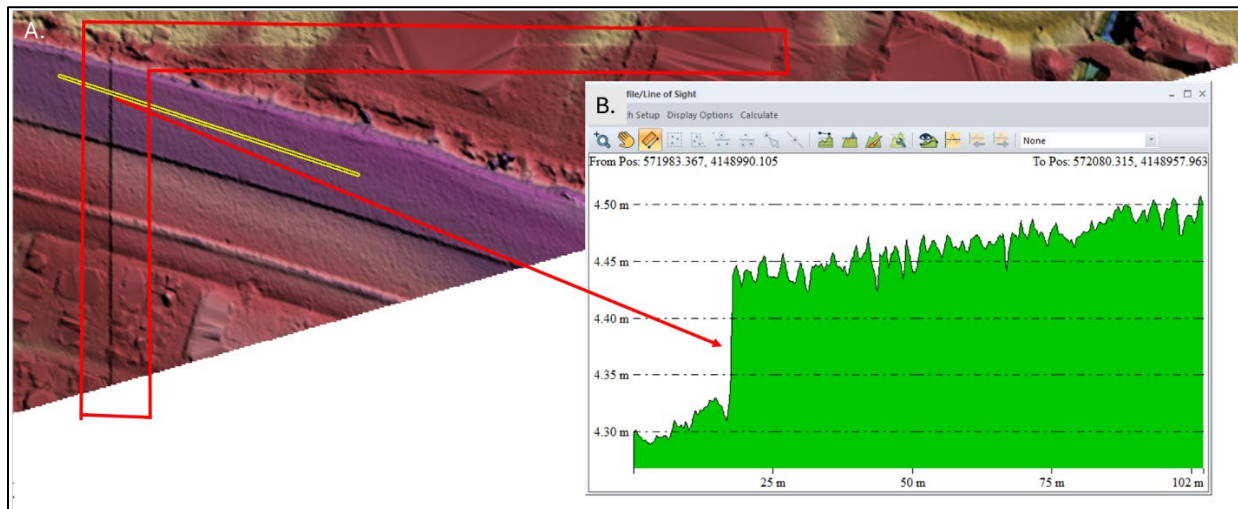
Mismatch

Elevation changes or gaps between two or more DEM tiles.

Figure 32. This illustration shows a mismatch in digital elevation models (A) along a tile border that shows up as a distortion. The mismatch can be seen in the elevation cross section (B) taken along double yellow line in A.

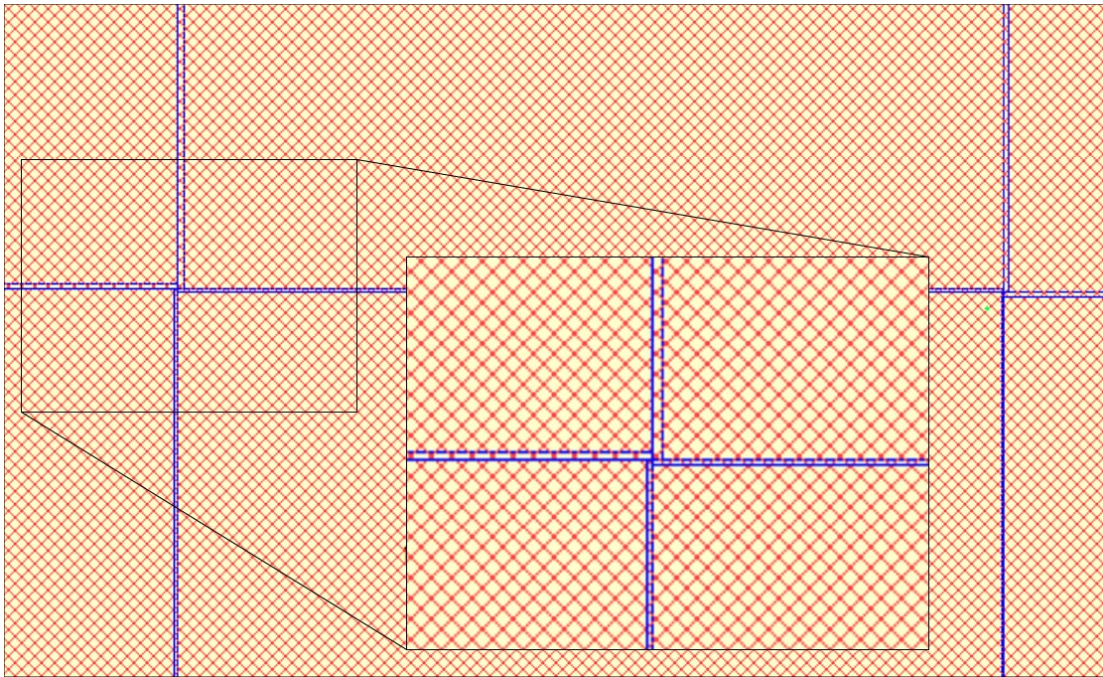
Overlap

When two or more adjacent DEM tiles overlay one another instead of edge matching.

Figure 33. Digital elevation tiles overlapping along tile boundaries (blue lines). The tiles should not overlap.

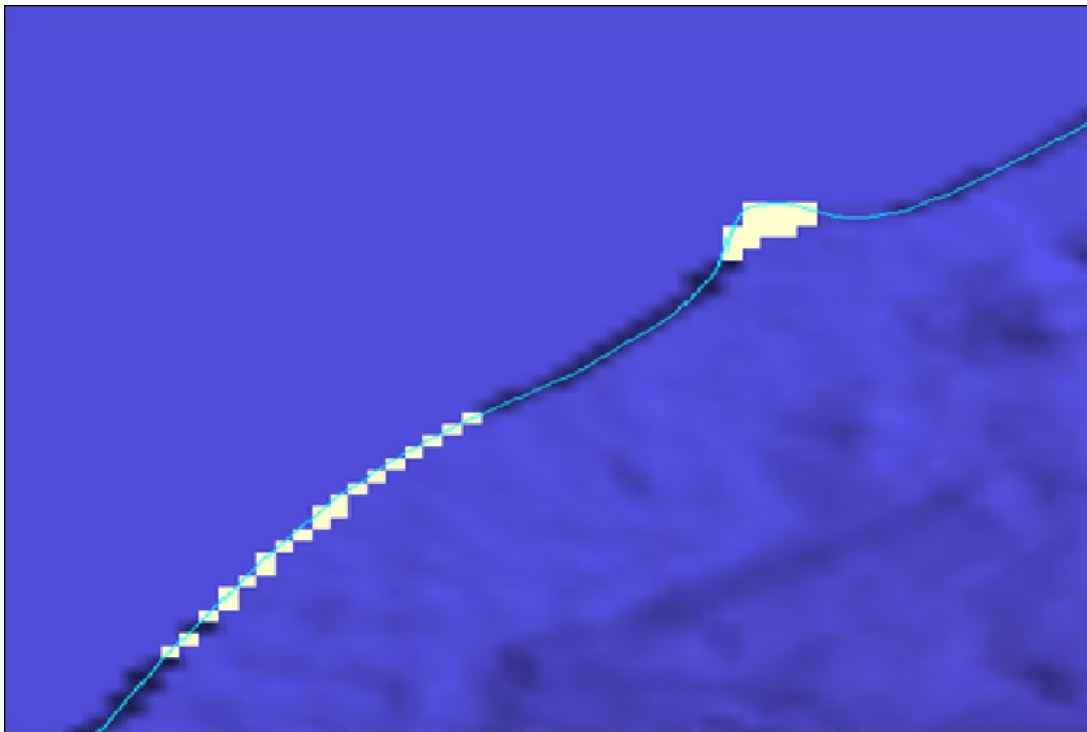
DEM Void

A specific type of interpolation error that is an area lacking data in the DEM, not due to point misclassifications or data voids in the point cloud.

Figure 34. Void (white pixels) in the digital elevation model occurring along a hydro breakline (green line).

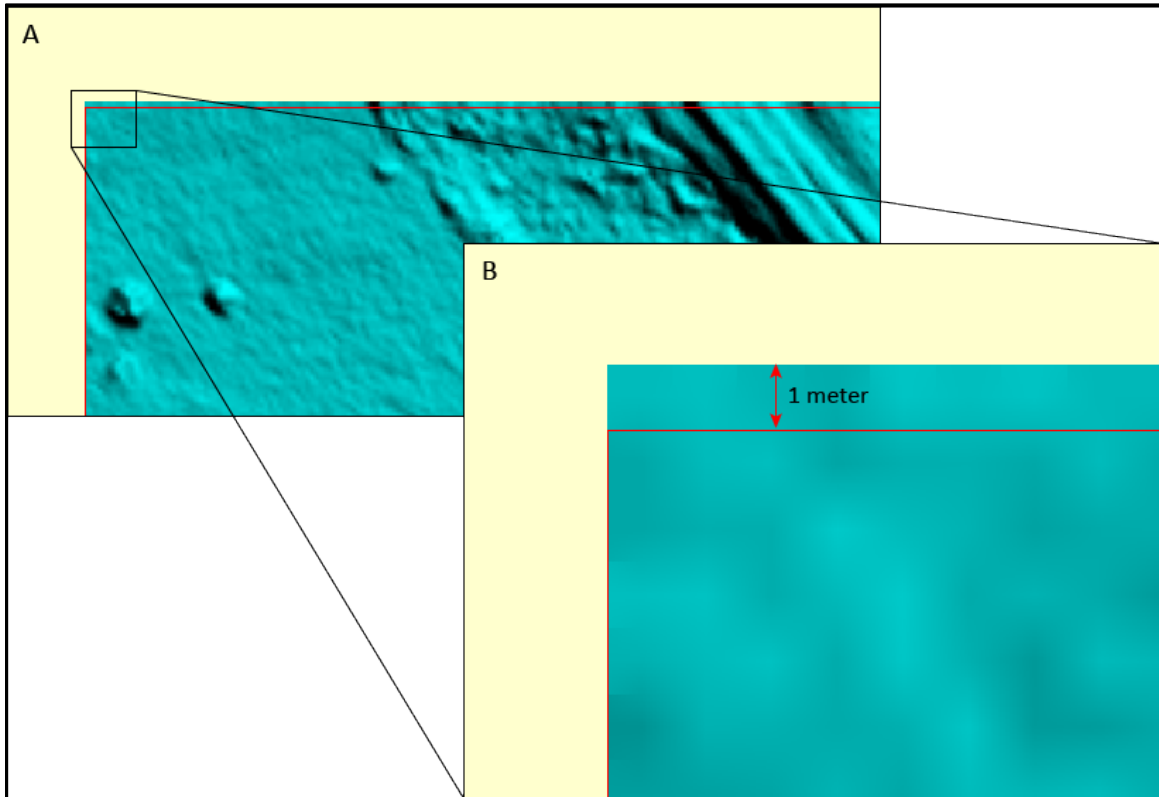
Does Not Match Project Extent

A delivered raster metadata product does not match the project's extent.

Figure 34: Digital elevation model raster metadata boundary (dark red) does not match the extent of the digital elevation model (blue).

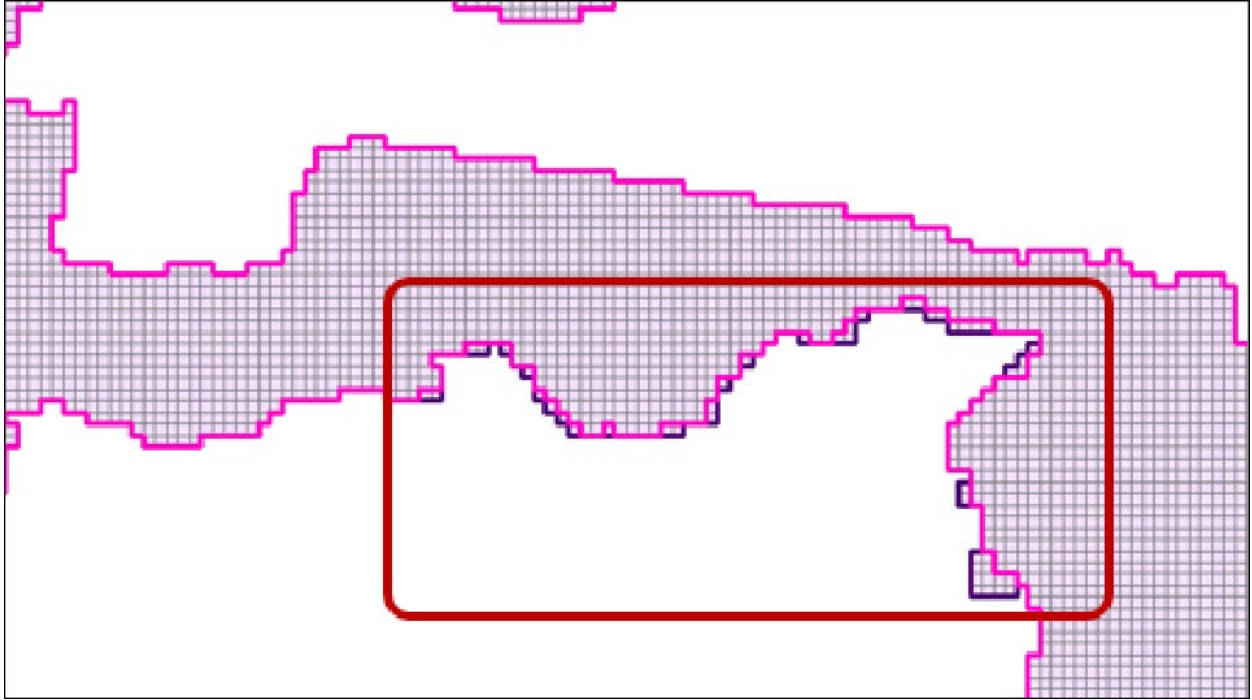
Incorrect Geometry

One or many aspects of the spatial features' geometry is incorrect. Description of error will be in text field.

Figure 35. Illustration of DPA boundary showing an incorrect geometry in the project (purple line) in the area enclosed by the red rectangle.
