Cross section PR167 was established in 1977 in the upriver limb of a large meander bend of Powder River in Sections 21 and 28 of T6S, R50E (the bend described as “near Daily Ranch” by Gay *et al.*, 1998, *their* Figure 9). Resurveys were conducted during the years 1978-1980, 1982, 1984-1998, 2011, and 2014.

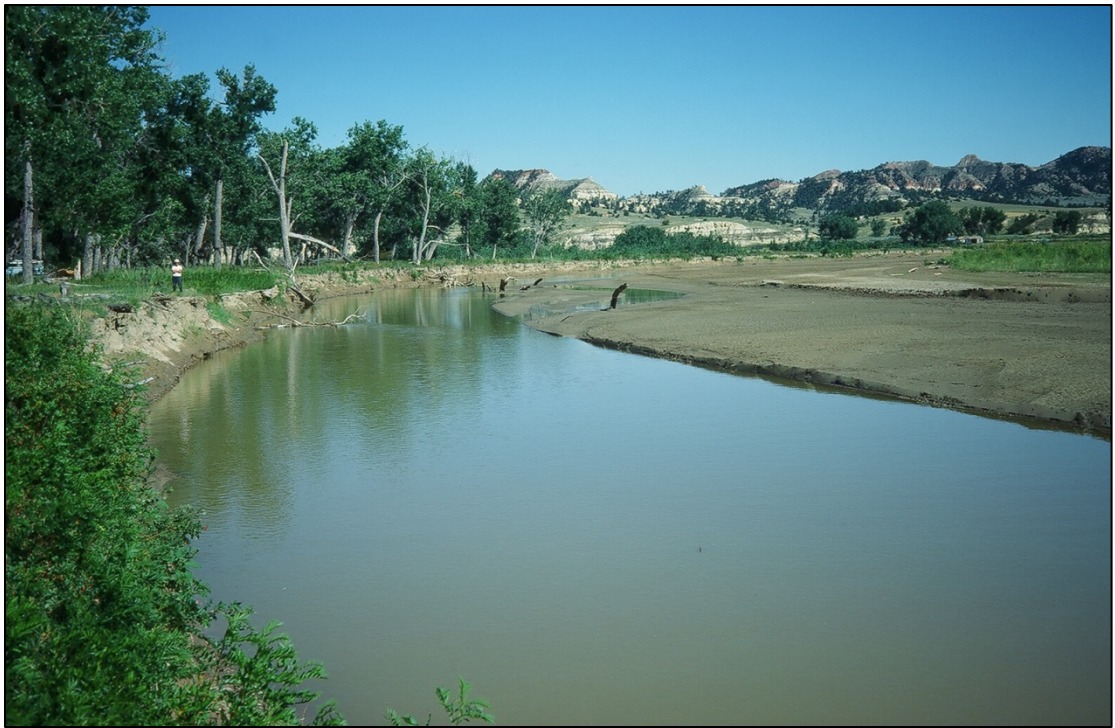
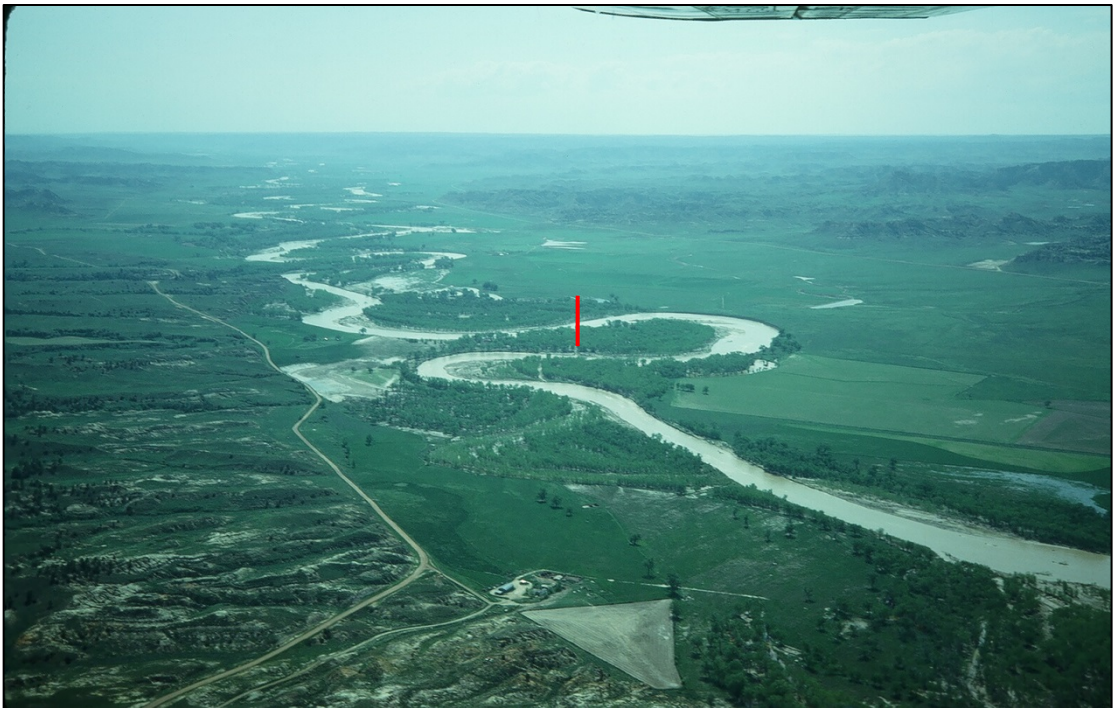
PR167. **Top.** 13 July 1977. View upriver along the right bank. E. Meade (~1.6 m tall) is standing on the line of section. **Bottom.** 25 May 1978. View upriver of bend near John Daily's Ranch during the Flood of 1978. Approximate line of section is shown by the red line.

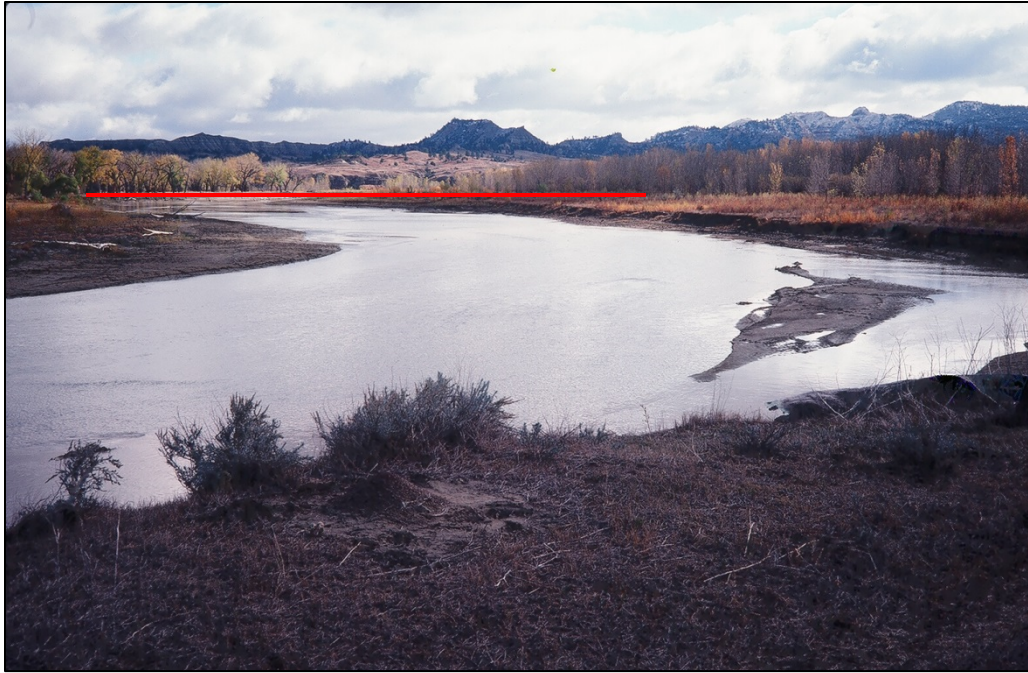
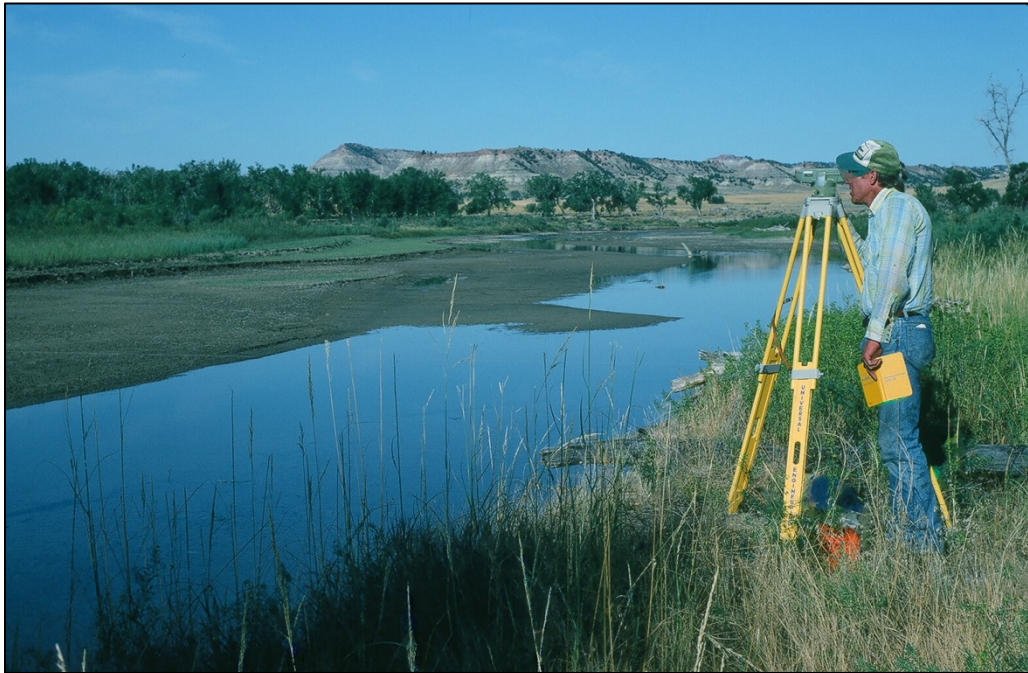
PR167. **Top.** 21 October 1979. View downriver. Left bank has seedlings of Russian olives brought in the Flood of 1978. Approximate location of the section is indicated by the red line. **Bottom.** 4 September 1991. View downriver from section. J. Moody (~1.9 m tall) is standing approximately on the line of section.

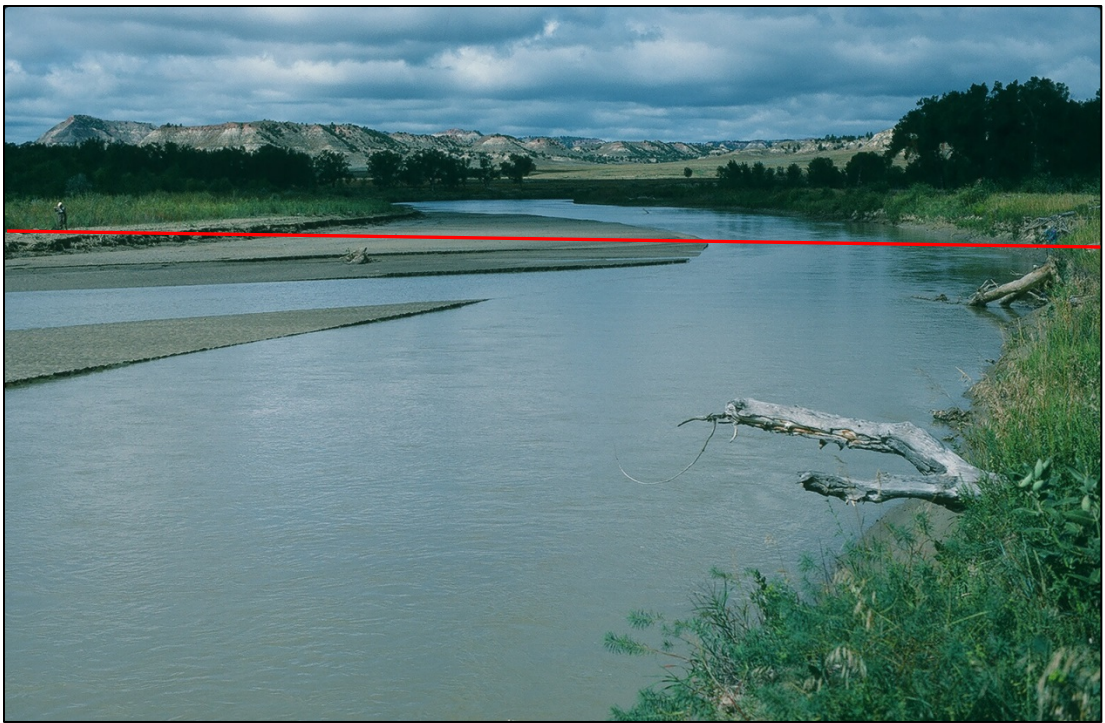
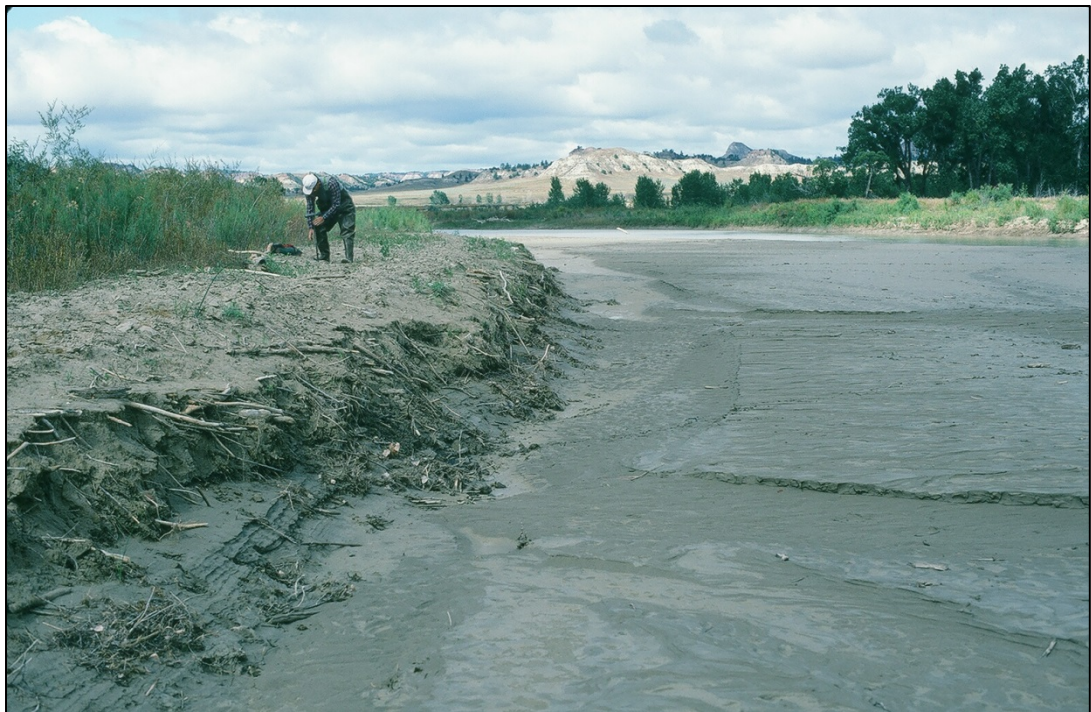
PR167. **Top.** 2 September 1993. View downriver. J. Pizzuto (~1.8 m tall) is on the line of section near station 60. **Bottom.** 2 September 1993. View downriver of new sand on point bar on left bank. J. Pizzuto is on the line of section near station 57. Red line indicates approximate location of section

Since the early 1990s, however, the shape of the cross-channel profile of section PR167 has altered significantly as the volume of new material that was deposited and accumulated on (and in) the left side of the channel, not only exceeded somewhat the volume of material eroded from the right-side cutbank, but accumulated in such a way as to narrow the width of the low-water channel of the river. The left bank of Powder River at cross section PR167, instead of being a gently-sloping surface as it was formerly, now has a levee (station 57-67), which is about 2 m above the sand bar along the left bank in 2014. The left bank is now stabilized (as of 2014) by a small but dense forest of Russian-olive trees that stand 3-4 m tall and extends from station

70 to station 10. From 1998 to 2014 under the Russian olives, no sand was deposited between stations 10 and 25 and about 0.03-0.05 m of sand was deposited between stations 25 and 57.

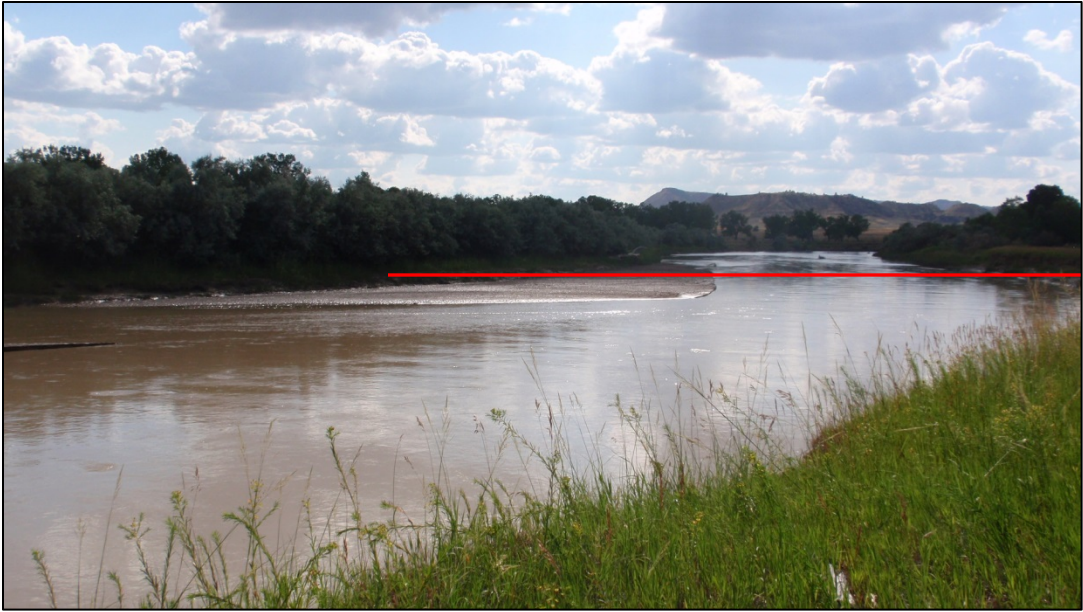
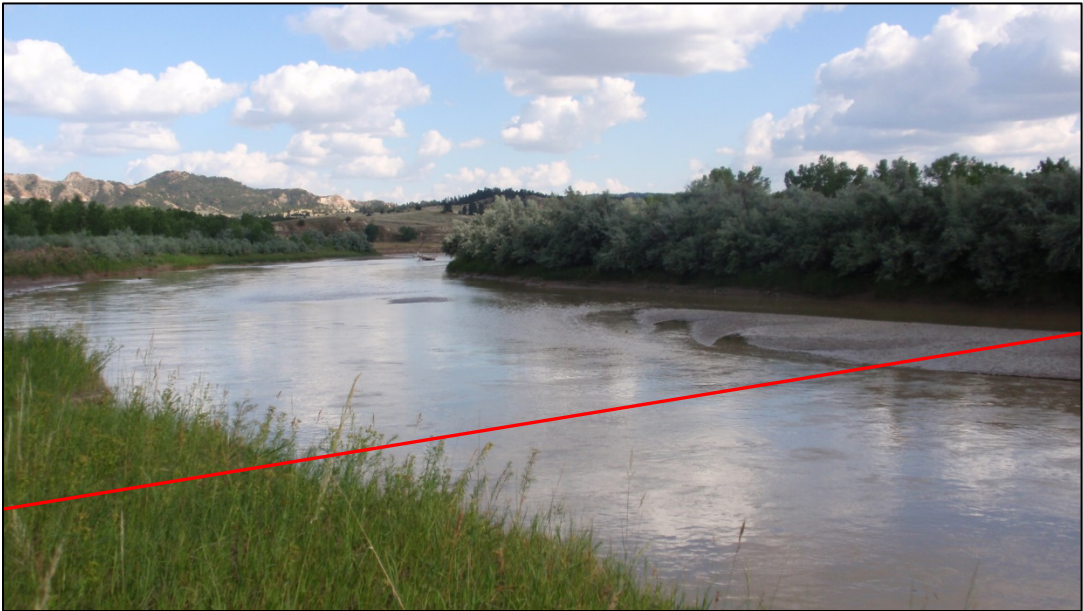
PR167. **Top.** 16 July 2014. View downriver from the right bank. Red line indicates the approximate line of section. **Bottom.** 16 July 2014. View upriver from the right bank. Red line indicates the approximate line of section.

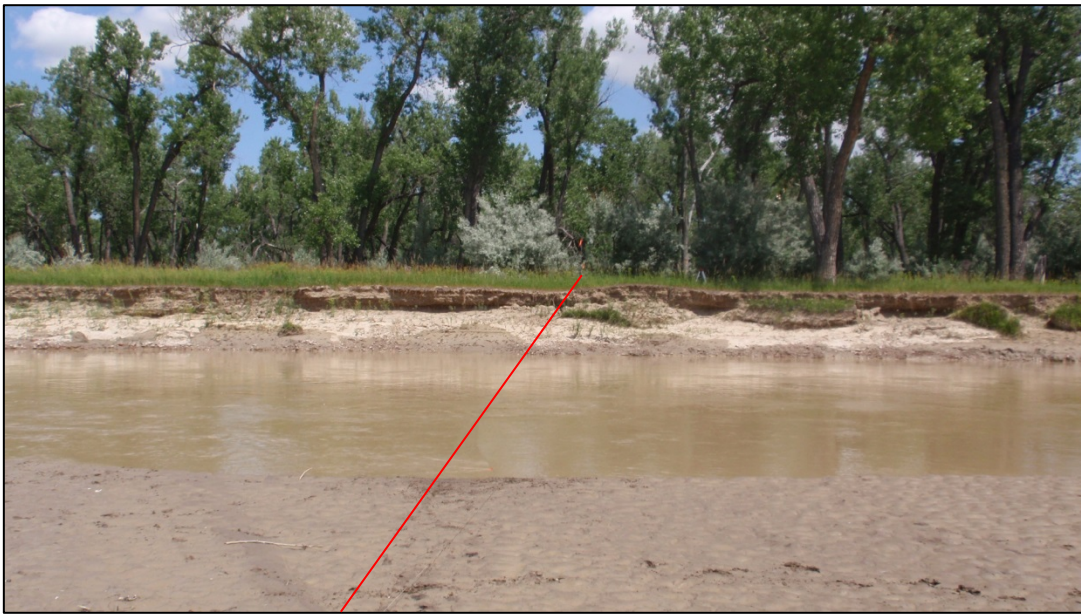
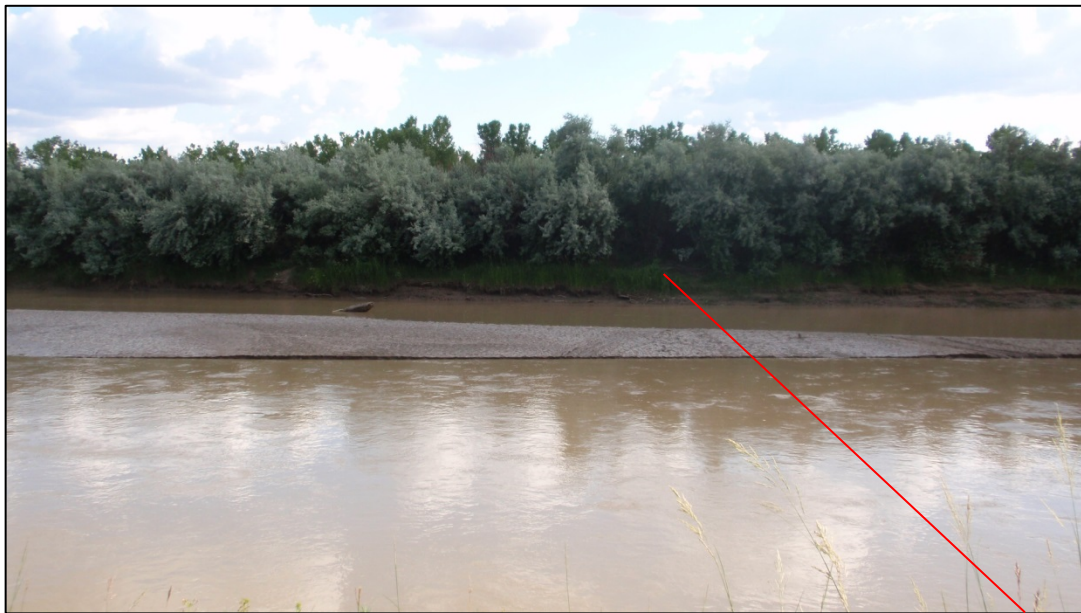
PR167. **Top.** 16 July 2014. Cross-channel view of the right bank. A metal pole with orange flagging is on the line of section. Red line indicates approximate location of section. **Bottom.** 16 July 2014. Cross-channel view of the left bank. Left-bank flood plain has a 60-m-wide thicket (from station 10 to station 70 that is approximately at the edge of the left bank) of 3-to-4-m-tall Russian olives, which have been trimmed along the line of section forming a narrow tunnel through the trees. Red line indicates approximate location of section.
