Monitoring Bank Erosion On the Missouri River, Lower Brule Reservation

A cooperative study between the Lower Brule Sioux Tribe's Environmental Protection Office and the U.S. Geological Survey, with assistance from the Oglala Lakota College.

This study was designed to monitor the physical changes that occur along the Missouri River bank during the study's two-year period, beginning Jan. 2011.

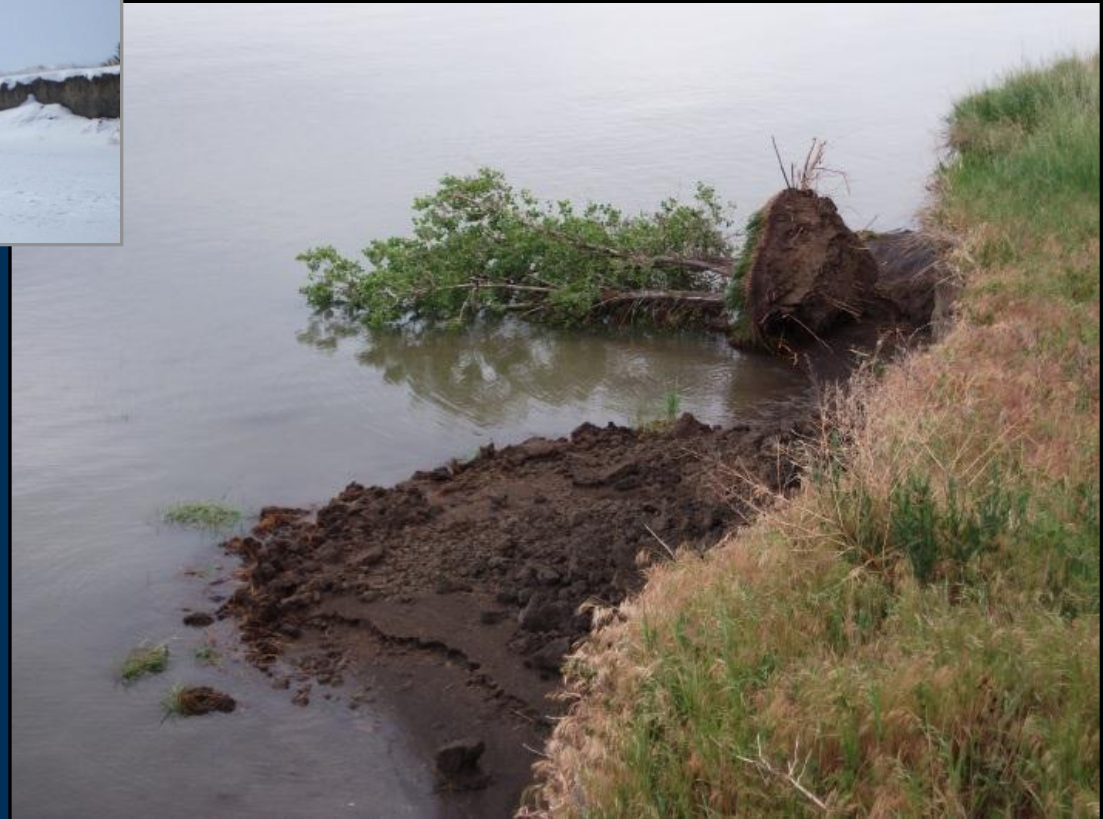
During a May, 2012 site visit, we found we will definitely have a measureable loss of soil as we found we had lost "our LiDAR tree" to erosion).

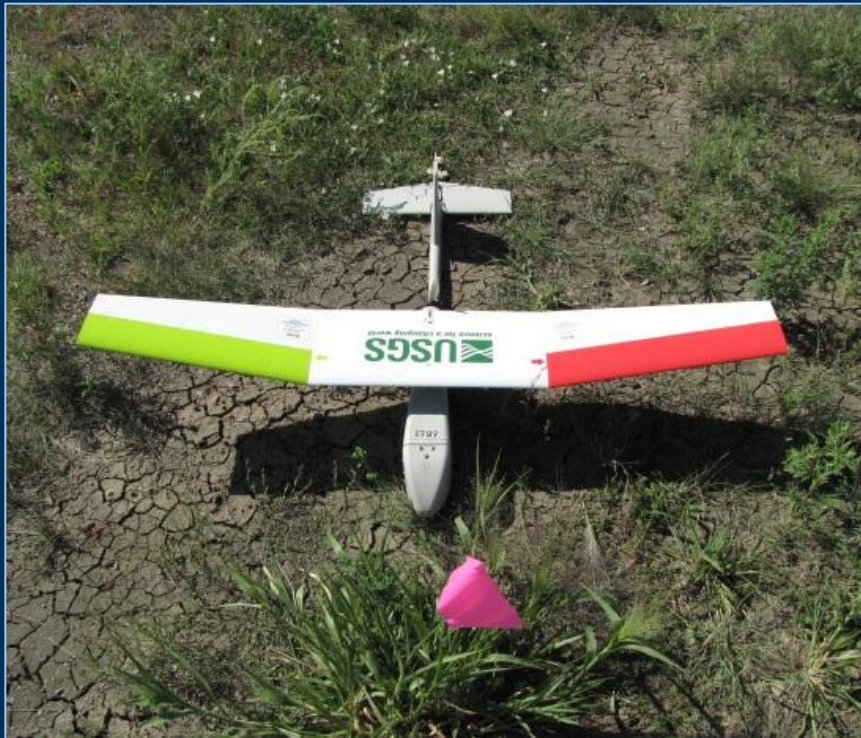
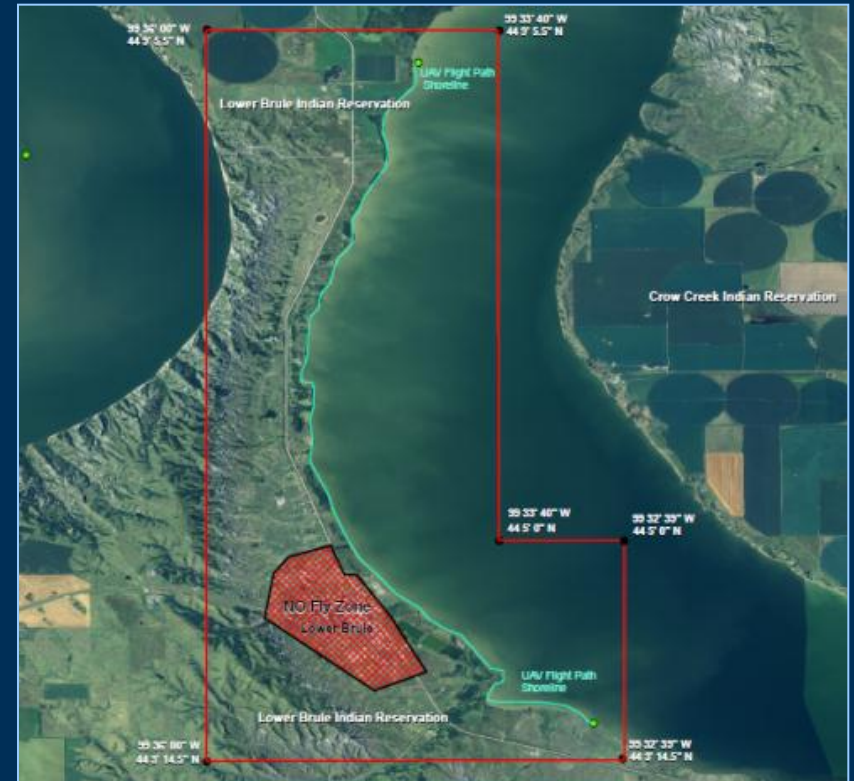
The small, unmanned aerial vehicle (UAV), used for this study was a Raven RQ-11A.

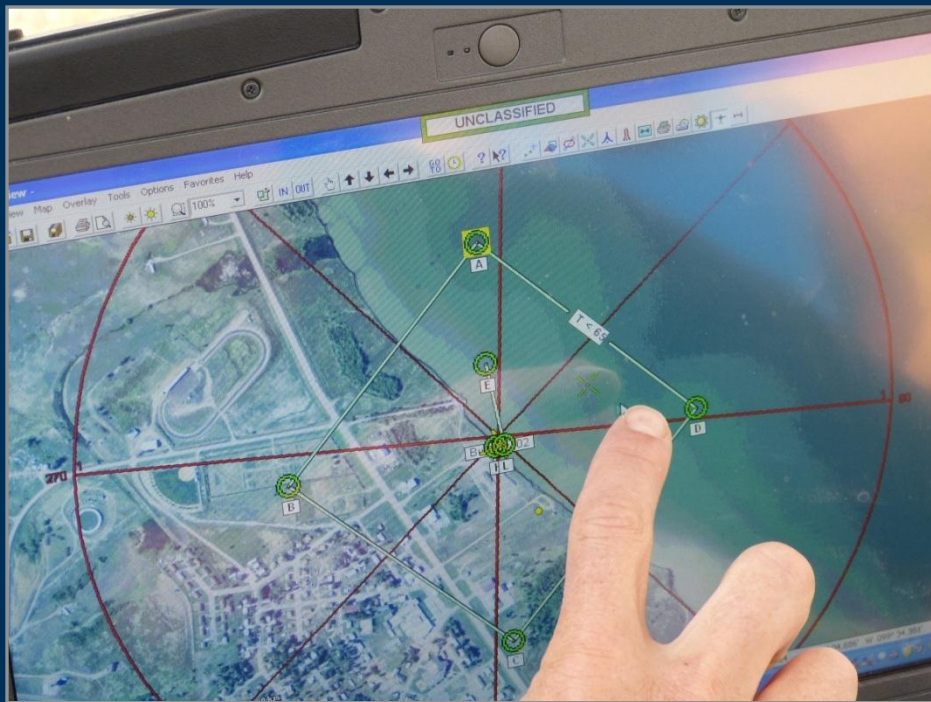
The laptop allows the mission controller to set flight points and view the UAS's location. The video window allows the controller to see to video that is being captured.

Once the UAS is in the air, it can also be flown by the laptop only, by moving the flight points.

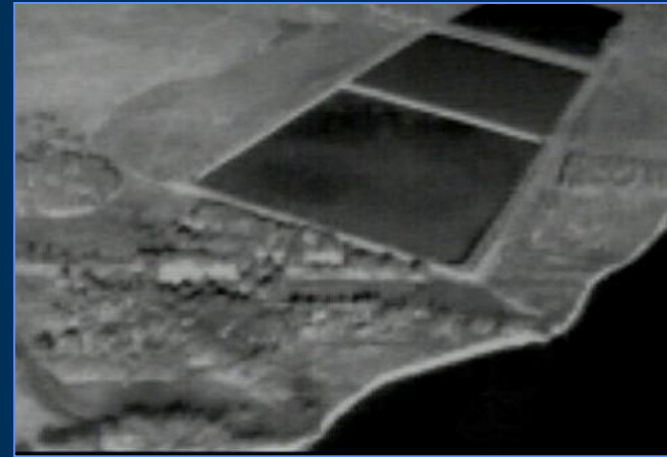
Captures from
IR camera
looking at the
lagoons:
Black-hot and
White-hot.

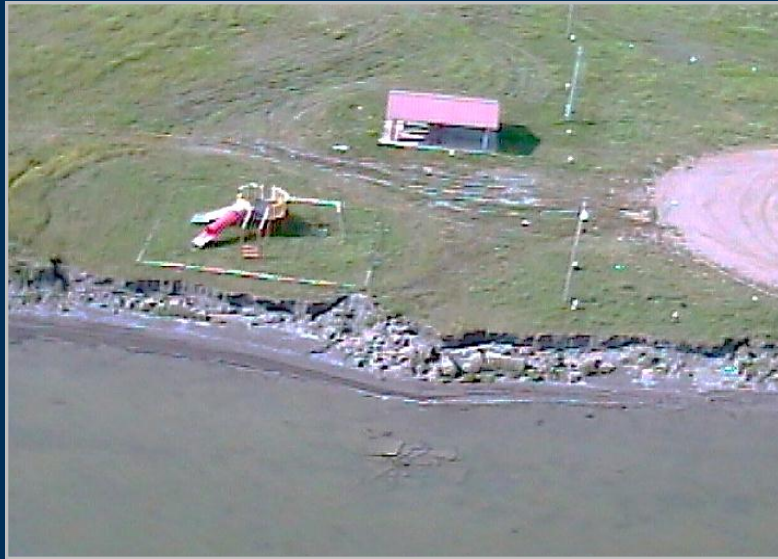
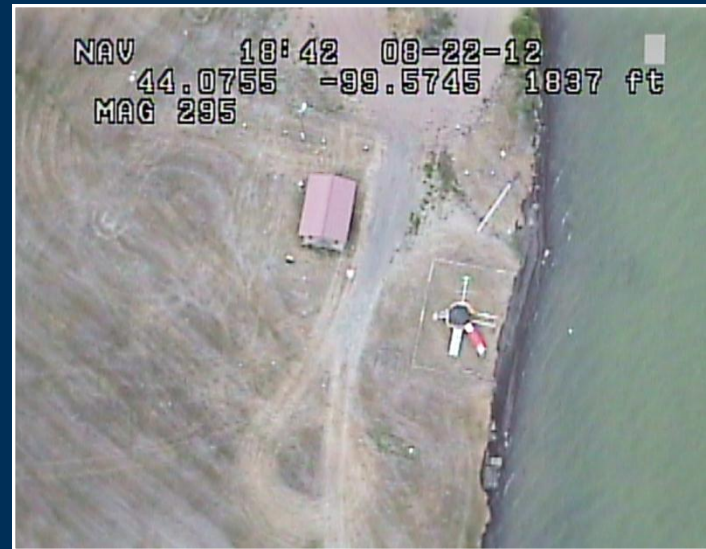
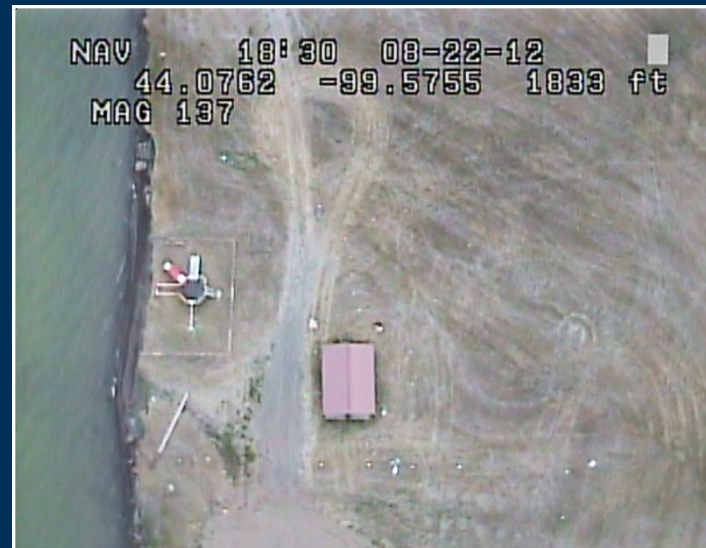
2011 flights provided baseline data.

2012 flights documented that the bank had eroded, allowing the front of the wood frame and surrounding soil to disappear during the year around this playground equipment.

This playground equipment is obviously in danger, but how long will it take to reach the bordering wood frame that is approx. 2 to 4 feet back?

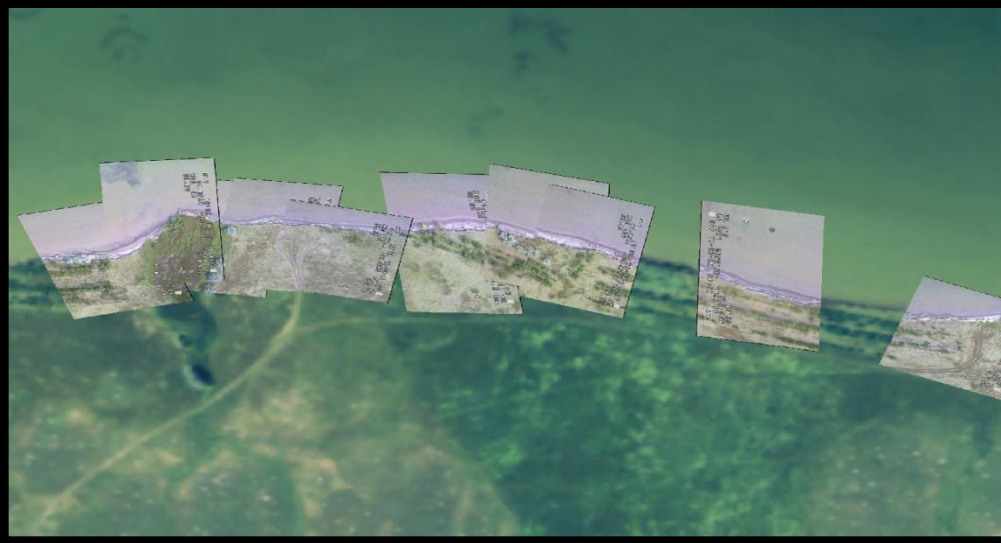
Comparing UAS Results With Other Types of Data

A technique called 'Rubber-Sheeting' was used to match the screen captures with the 2011 National Agriculture Imagery Program (NAIP) data by visually examining the photos & metadata.

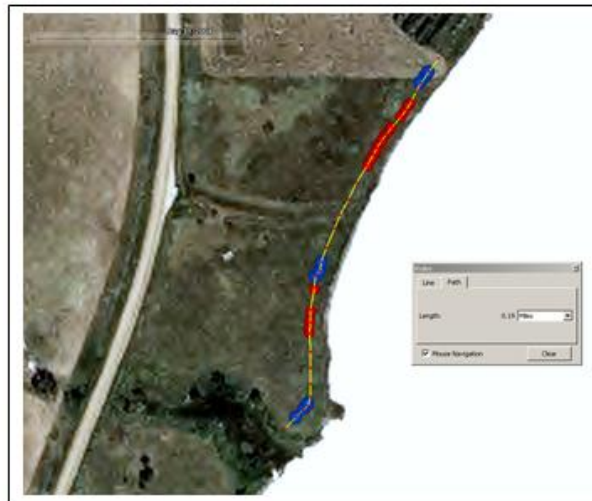
Estimated change in the recent six years (from 2004 to 2010) by measuring from the blue markers to the shoreline shown on the image.

Estimated change (in feet):

Northern: 35-39
Central: 36-38
Southern: 65-82
